Access Compliance Report

Public Rights-of-Way

(Curb Ramps)

Intersection ID: 10154	Main Street: SLOAN_DR	Cross Street: TUCKASEEGEE_RD	Location: W
ADA ID: EAFE26689BFE	Ramp Type: Combination1	Initial Pass/Fail: Fail	Overall Compliance: No
Severity Score: 58.75			
Codes/Mitigation Info/Possible Solution		Field Measurements/Component Compliance

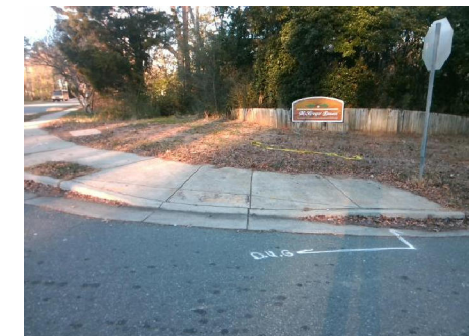
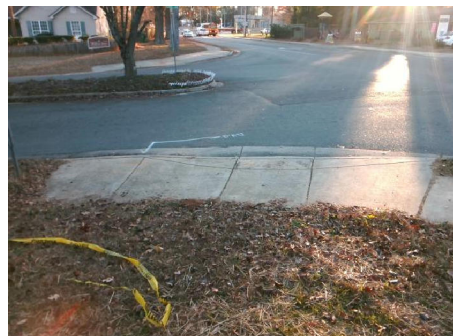
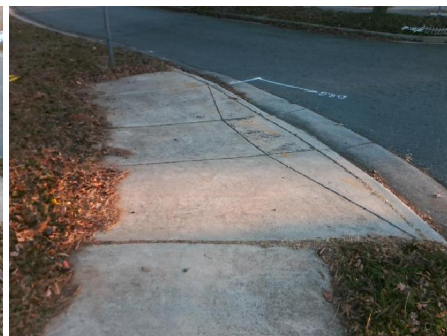
Not Found, R304.5.1, R304.2.2, R304.5.3, R304.3.2

Compliance	Description	Data	Compliance	Description	Data
N/A	Ramp Length LT (in)	42.0	N/A	Ramp Length RT (in)	53.0
Yes	Ramp Width LT (in)	84.0	Yes	Ramp Width RT (in)	84.0
No	Ramp Slope LT (%)	12.0	Yes	Ramp Slope RT (%)	6.1
No	Ramp XSlope LT (%)	4.2	No	Ramp XSlope RT (%)	8.1
N/A	Ramp Length (in)	84.0	No	Ramp Slope (%)	8.4
No	Ramp Width (in)	39.5	No	Ramp XSlope (%)	8.1
N/A	Flare Type LT	N/A	N/A	Flare Type RT	N/A
N/A	Flare Slope LT (%)	N/A	N/A	Flare Slope RT (%)	N/A
N/A	Flare Traversable LT?	N/A	N/A	Flare Traversable RT?	N/A
N/A	Landing Length (in)	N/A	N/A	DWS Provided?	N/A
N/A	Landing Width (in)	N/A	N/A	DWS Contrast?	N/A
N/A	Landing Slope (%)	N/A	N/A	DWS Length (in)	N/A
N/A	Landing X Slope (%)	N/A	N/A	DWS Full Width?	N/A
N/A	Landing Curb? (Y/N)	N/A	N/A	DWS Offset (in)	N/A
N/A	Shared Landing?	N/A			
N/A	Gutter Ponding?	N/A	N/A	Gutter Slope (%)	N/A
N/A	Gutter Lip Ht (in)	N/A	N/A	Gutter X Slope (%)	N/A
N/A	Painted X Walk1?	No	N/A	Painted X Walk2?	N/A

X Walk 1 Direction	To E		X Walk 2 Direction	N/A
	X Walk 1 Width (in)	N/A		X Walk 2 Width (in)	N/A
	X Walk 1 Slope (%)	2.9		X Walk 2 Slope (%)	N/A
	X Walk 1 X Slope (%)	7.6		X Walk 2 X Slope (%)	N/A
N/A	Ramp inside XWalk1?	N/A	N/A	Ramp inside XWalk2?	N/A
	Road Slope (%)	N/A		Clear Space?	N/A
	Road X Slope (%)	N/A	N/A	Clear Space to XWalk (in)	N/A
			N/A	Any Obstruction?	N/A
				Obstruction Type	N/A
			N/A	Storm Grate/Utility Hazard?	N/A
				Storm Grate/Utility Type	N/A
Yes	Surface Condition? (G/P)	Good			
	Curb Slope (%)	13.0

Possible Solutions:

Remove & Replace Entire Ramp.
