# Access Compliance Report

## Public Rights-of-Way

### (Curb Ramps)

Intersection ID: 14711	Main Street: VAIL_AV	Cross Street: VAN_NESS_ST	Location: NW
ADA ID: EB0CCC2D23C2	Ramp Type: PerpDiag	Initial Pass/Fail: Pass	Overall Compliance: No
Severity Score: 10.25			
Codes/Mitigation Info/Possible Solution		Field Measurements/Component Compliance

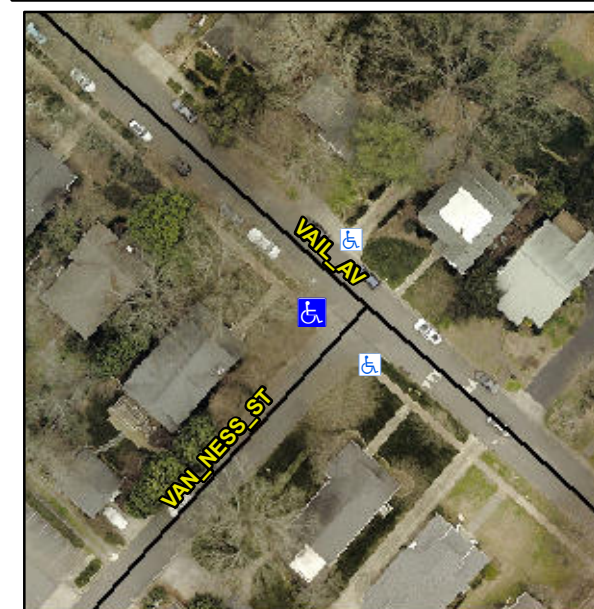
**Not Found, R304.5.3, R305**

Compliance	Description	Data	Compliance	Description	Data
N/A	Ramp Length (in)	63.0	Yes	Ramp Slope (%)	7.3
Yes	Ramp Width (in)	54.0	No	Ramp XSlope (%)	3.1
N/A	Flare Type LT	Sloped	N/A	Flare Type RT	N/A
N/A	Flare Slope LT (%)	11.8	N/A	Flare Slope RT (%)	6.5
N/A	Flare Traversable LT?	No	N/A	Flare Traversable RT?	No
Yes	Landing Length (in)	48.0	No	DWS Provided?	No
Yes	Landing Width (in)	54.0	N/A	DWS Contrast?	No
Yes	Landing Slope (%)	1.8	N/A	DWS Length (in)	N/A
Yes	Landing X Slope (%)	1.9	N/A	DWS Full Width?	No
N/A	Landing Curb? (Y/N)	No	N/A	DWS Offset (in)	N/A
N/A	Shared Landing?	No			
Yes	Gutter Ponding?	No	Yes	Gutter Slope (%)	2.3
Yes	Gutter Lip Ht (in)	0.0	Yes	Gutter X Slope (%)	0.8
N/A	Painted X Walk1?	No	N/A	Painted X Walk2?	No
	X Walk 1 Direction	To SE		X Walk 2 Direction	To NE
N/A	X Walk 1 Width (in)	N/A	N/A	X Walk 2 Width (in)	N/A
	X Walk 1 Slope (%)	2.6		X Walk 2 Slope (%)	3.3
	X Walk 1 X Slope (%)	3.5		X Walk 2 X Slope (%)	0.5

N/A	Ramp inside XWalk1?	N/A	N/A	Ramp inside XWalk2?	N/A
	Road Slope (%)	3.5	N/A	Clear Space?	Yes
	Road X Slope (%)	0.2	N/A	Clear Space to XWalk (in)	N/A
Yes	Any Obstructions?	No	Yes	Storm Grate/Utility Hazard?	No
	Obstruction Type			Storm Grate/Utility Type	
		N/A			N/A
		Yes		Surface Condition? (G/P)	Good

Possible Solutions:

**Remove & Replace Curb Ramp With Two New Directional Ramps or Equivalent.**

Total Cost: \$ 3200.00
