# Access Compliance Report

## Public Rights-of-Way

Intersection ID: 11910	Main Street: E_W_T_HARRIS_BV	Cross Street: ROBINSON_CHURCH_RD	Location: NE
ADA ID: EB11B97CFA3A	Ramp Type: PerpDiag	Initial Pass/Fail: Fail	Overall Compliance: No
Severity Score: 26.25			
Codes/Mitigation Info/Possible Solution		Field Measurements/Component Compliance

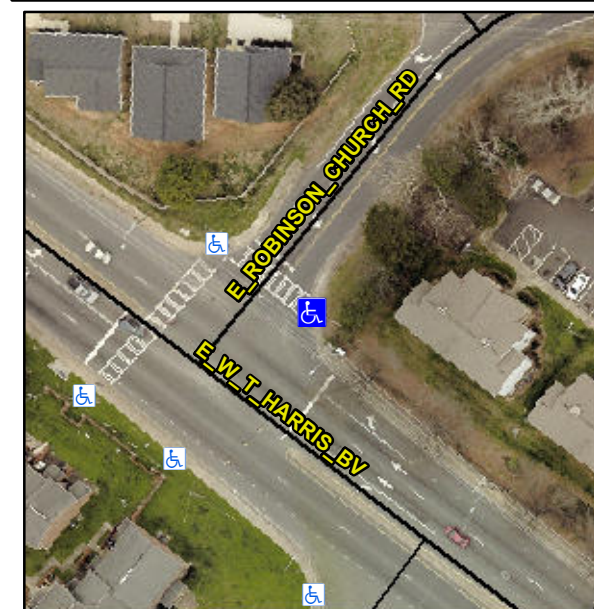
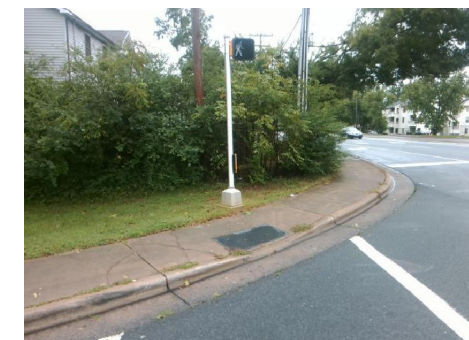
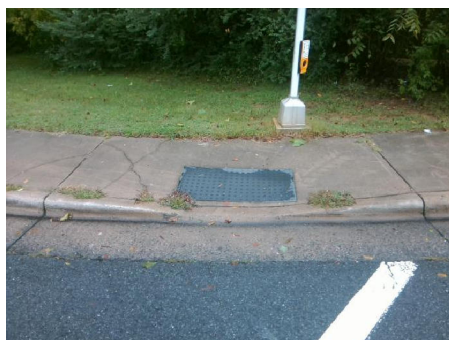
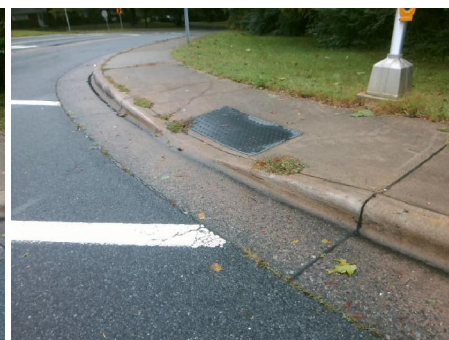
Compliance	Description	Data	Compliance	Description	Data
N/A	Ramp Length (in)	58.0	No	Ramp Slope (%)	12.8
Yes	Ramp Width (in)	48.0	Yes	Ramp XSlope (%)	3.4
N/A	Flare Type LT	N/A	N/A	Flare Type RT	N/A
N/A	Flare Slope LT (%)	N/A	N/A	Flare Slope RT (%)	N/A
N/A	Flare Traversable LT?	N/A	N/A	Flare Traversable RT?	N/A
N/A	Landing Length (in)	N/A	N/A	DWS Provided?	N/A
N/A	Landing Width (in)	N/A	N/A	DWS Contrast?	N/A
N/A	Landing Slope (%)	N/A	N/A	DWS Length (in)	N/A
N/A	Landing X Slope (%)	N/A	N/A	DWS Full Width?	N/A
N/A	Landing Curb? (Y/N)	N/A	N/A	DWS Offset (in)	N/A
N/A	Shared Landing?	N/A			
N/A	Gutter Ponding?	N/A	N/A	Gutter Slope (%)	N/A
N/A	Gutter Lip Ht (in)	0.5	N/A	Gutter X Slope (%)	N/A
N/A	Painted X Walk1?	Yes	N/A	Painted X Walk2?	No
	X Walk 1 Direction	To NW		X Walk 2 Direction	To SW
N/A	X Walk 1 Width (in)	117.0	N/A	X Walk 2 Width (in)	N/A
	X Walk 1 Slope (%)	2.8		X Walk 2 Slope (%)	6.0
	X Walk 1 X Slope (%)	6.6		X Walk 2 X Slope (%)	0.6

N/A	Ramp inside XWalk1?	Yes	N/A	Ramp inside XWalk2?	N/A
	Road Slope (%)	5.2	N/A	Clear Space?	N/A
	Road X Slope (%)	7.8	N/A	Clear Space to XWalk (in)	N/A
N/A	Any Obstructions?	N/A	N/A	Storm Grate/Utility Hazard?	N/A
	Obstruction Type			Storm Grate/Utility Type	
		N/A			N/A
		Yes		Surface Condition? (G/P)	Good

**Remove & Replace Curb Ramp With Two New Directional Ramps or Equivalent.**
