# Access Compliance Report

## Public Rights-of-Way

### (Curb Ramps)

Intersection ID: 6562	Main Street: BRADEN_DR	Cross Street: CAPPS_HILL_MINE_RD	Location: SE
ADA ID: EB288EFBF939	Ramp Type: Perp	Initial Pass/Fail: Fail	Overall Compliance: No
		Severity Score: 25

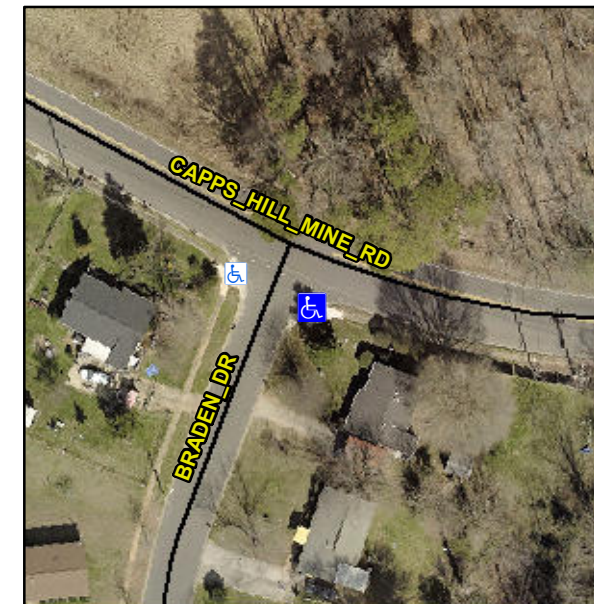
**Not Found, R304.5.3**

Compliance	Description	Data	Compliance	Description	Data
N/A	Ramp Length (in)	50.0	Yes	Ramp Slope (%)	7.5
Yes	Ramp Width (in)	62.0	No	Ramp XSlope (%)	13.6
N/A	Flare Type LT	N/A	N/A	Flare Type RT	N/A
N/A	Flare Slope LT (%)	N/A	N/A	Flare Slope RT (%)	N/A
N/A	Flare Traversable LT?	N/A	N/A	Flare Traversable RT?	N/A
N/A	Landing Length (in)	N/A	N/A	DWS Provided?	N/A
N/A	Landing Width (in)	N/A	N/A	DWS Contrast?	N/A
N/A	Landing Slope (%)	N/A	N/A	DWS Length (in)	N/A
N/A	Landing X Slope (%)	N/A	N/A	DWS Full Width?	N/A
N/A	Landing Curb? (Y/N)	N/A	N/A	DWS Offset (in)	N/A
N/A	Shared Landing?	N/A			
N/A	Gutter Ponding?	N/A	N/A	Gutter Slope (%)	N/A
N/A	Gutter Lip Ht (in)	N/A	N/A	Gutter X Slope (%)	N/A
N/A	Painted X Walk1?	No	N/A	Painted X Walk2?	N/A
	X Walk 1 Direction	To NW		X Walk 2 Direction	N/A
N/A	X Walk 1 Width (in)	N/A	N/A	X Walk 2 Width (in)	N/A
	X Walk 1 Slope (%)	7.3		X Walk 2 Slope (%)	N/A
	X Walk 1 X Slope (%)	8.0		X Walk 2 X Slope (%)	N/A

N/A	Ramp inside XWalk1?	N/A	N/A	Ramp inside XWalk2?	N/A
	Road Slope (%)	N/A	N/A	Clear Space?	N/A
	Road X Slope (%)	N/A	N/A	Clear Space to XWalk (in)	N/A
N/A	Any Obstructions?	N/A	N/A	Storm Grate/Utility Hazard?	N/A
	Obstruction Type			Storm Grate/Utility Type	
		N/A			N/A
			Yes	Surface Condition? (G/P)	Good

**Remove & Replace Entire Ramp.**
