# Access Compliance Report

## Public Rights-of-Way

### (Curb Ramps)

Intersection ID: 12190	Main Street: E_16TH_ST	Cross Street: PEGRAM_ST	Location: E
ADA ID: EB34701AD675	Ramp Type: Perp	Initial Pass/Fail: Fail	Overall Compliance: No
Severity Score: 21.25			
Codes/Mitigation Info/Possible Solution		Field Measurements/Component Compliance

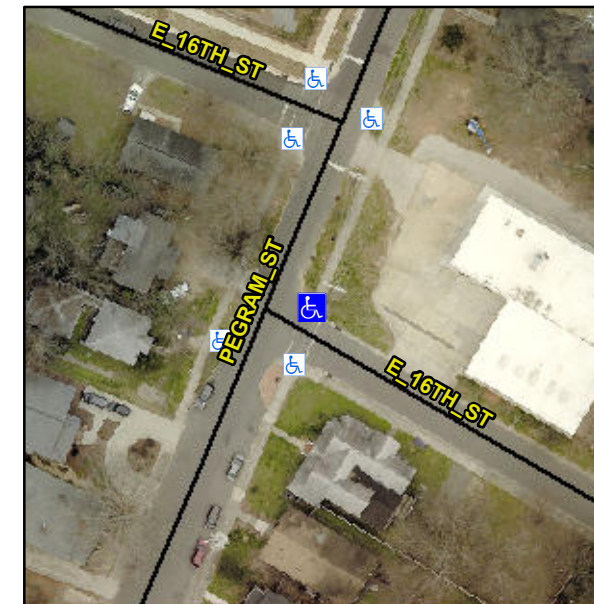
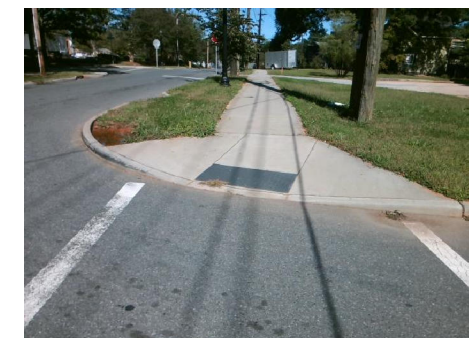
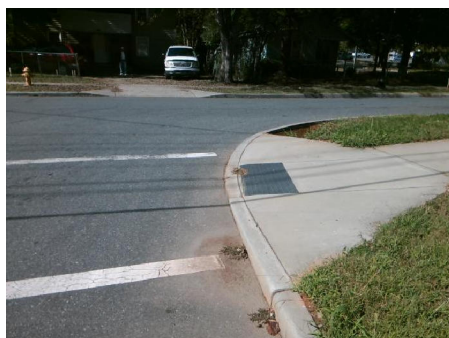
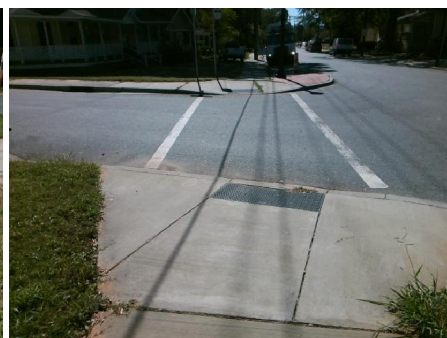
**Not Found, R304.5.1, R304.2.2**

Compliance	Description	Data	Compliance	Description	Data
N/A	Ramp Length (in)	91.5	No	Ramp Slope (%)	10.4
No	Ramp Width (in)	47.5	Yes	Ramp XSlope (%)	1.1
N/A	Flare Type LT	N/A	N/A	Flare Type RT	N/A
N/A	Flare Slope LT (%)	N/A	N/A	Flare Slope RT (%)	N/A
N/A	Flare Traversable LT?	N/A	N/A	Flare Traversable RT?	N/A
N/A	Landing Length (in)	N/A	N/A	DWS Provided?	N/A
N/A	Landing Width (in)	N/A	N/A	DWS Contrast?	N/A
N/A	Landing Slope (%)	N/A	N/A	DWS Length (in)	N/A
N/A	Landing X Slope (%)	N/A	N/A	DWS Full Width?	N/A
N/A	Landing Curb? (Y/N)	N/A	N/A	DWS Offset (in)	N/A
N/A	Shared Landing?	N/A			
N/A	Gutter Ponding?	N/A	N/A	Gutter Slope (%)	N/A
N/A	Gutter Lip Ht (in)	N/A	N/A	Gutter X Slope (%)	N/A
N/A	Painted X Walk1?	Yes	N/A	Painted X Walk2?	N/A
	X Walk 1 Direction	To SW		X Walk 2 Direction	N/A
N/A	X Walk 1 Width (in)	112.0	N/A	X Walk 2 Width (in)	N/A
	X Walk 1 Slope (%)	0.3		X Walk 2 Slope (%)	N/A
	X Walk 1 X Slope (%)	1.5		X Walk 2 X Slope (%)	N/A

N/A	Ramp inside XWalk1?	Yes	N/A	Ramp inside XWalk2?	N/A
	Road Slope (%)	N/A	N/A	Clear Space?	N/A
	Road X Slope (%)	N/A	N/A	Clear Space to XWalk (in)	N/A
N/A	Any Obstructions?	N/A	N/A	Storm Grate/Utility Hazard?	N/A
	Obstruction Type			Storm Grate/Utility Type	
		N/A			N/A
			Yes	Surface Condition? (G/P)	Good

**Remove & Replace Entire Ramp.**

Total Cost: \$ 1850.00
