# Access Compliance Report

## Public Rights-of-Way

### (Curb Ramps)

Intersection ID: 47970	Main Street: KYRENE_RD	Cross Street: HAWK_SHADOW_LN	Location: SW
ADA ID: EB357466BBE1	Ramp Type: PerpDiag	Initial Pass/Fail: Fail	Overall Compliance: No
Severity Score: 10			
Codes/Mitigation Info/Possible Solution		Field Measurements/Component Compliance

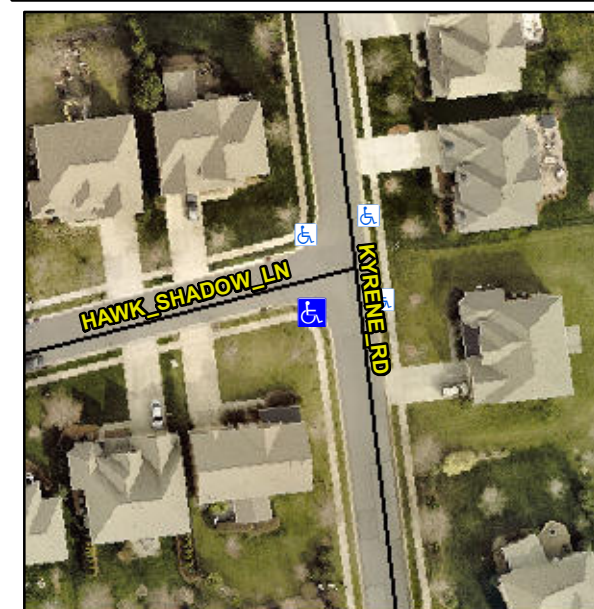
Compliance	Description	Data	Compliance	Description	Data
N/A	Ramp Length (in)	48.0	Yes	Ramp Slope (%)	7.2
No	Ramp Width (in)	47.0	No	Ramp XSlope (%)	2.7
N/A	Flare Type LT	N/A	N/A	Flare Type RT	N/A
N/A	Flare Slope LT (%)	N/A	N/A	Flare Slope RT (%)	N/A
N/A	Flare Traversable LT?	N/A	N/A	Flare Traversable RT?	N/A
N/A	Landing Length (in)	N/A	N/A	DWS Provided?	N/A
N/A	Landing Width (in)	N/A	N/A	DWS Contrast?	N/A
N/A	Landing Slope (%)	N/A	N/A	DWS Length (in)	N/A
N/A	Landing X Slope (%)	N/A	N/A	DWS Full Width?	N/A
N/A	Landing Curb? (Y/N)	N/A	N/A	DWS Offset (in)	N/A
N/A	Shared Landing?	N/A			
N/A	Gutter Ponding?	N/A	N/A	Gutter Slope (%)	N/A
N/A	Gutter Lip Ht (in)	N/A	N/A	Gutter X Slope (%)	N/A
N/A	Painted X Walk1?	No	N/A	Painted X Walk2?	No
	X Walk 1 Direction	To E		X Walk 2 Direction	To N
N/A	X Walk 1 Width (in)	N/A	N/A	X Walk 2 Width (in)	N/A
	X Walk 1 Slope (%)	4.0		X Walk 2 Slope (%)	1.6
	X Walk 1 X Slope (%)	0.2		X Walk 2 X Slope (%)	2.8

N/A	Ramp inside XWalk1?	N/A	N/A	Ramp inside XWalk2?	N/A
	Road Slope (%)	3.6	N/A	Clear Space?	N/A
	Road X Slope (%)	3.5	N/A	Clear Space to XWalk (in)	N/A
N/A	Any Obstructions?	N/A	N/A	Storm Grate/Utility Hazard?	N/A
	Obstruction Type			Storm Grate/Utility Type	
		N/A			N/A
		Yes		Surface Condition? (G/P)	Good

Possible Solutions:

**Remove & Replace Curb Ramp With Two New Directional Ramps or Equivalent.**

**R304.5.1, R304.5.3**
