Access Compliance Report

Public Rights-of-Way

(Curb Ramps)

Intersection ID: N/A	Main Street: 3RD_ST	Cross Street: JOHN_BELK_FY	Location: S
ADA ID: EB3823553F19	Ramp Type: Directional1	Initial Pass/Fail: Pass	Overall Compliance: No
		Severity Score: 0

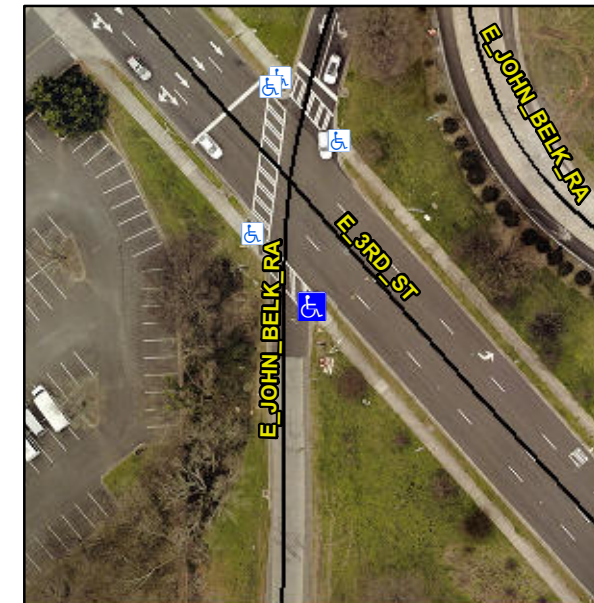
Not Found, R304.2.2-Perp, R304.3.2-Para, R304.5.2

Compliance	Description	Data	Compliance	Description	Data
N/A	Ramp Length (in)	80.0	No	Grade Break?	No
Yes	Ramp Width (in)	140.0	N/A	Grade Break Slope (%)	N/A
Yes	Ramp Slope (%)	2.0	N/A	Grade Break XSlope (%)	N/A
Yes	Ramp XSlope (%)	1.0			
N/A	Flare Type LT	N/A	N/A	Flare Type RT	N/A
N/A	Flare Slope LT (%)	N/A	N/A	Flare Slope RT (%)	N/A
N/A	Flare Traversable LT?	N/A	N/A	Flare Traversable RT?	N/A
Yes	Landing Length (in)	60.0	Yes	DWS Provided?	Yes
Yes	Landing Width (in)	84.0	Yes	DWS Contrast?	Yes
No	Landing Slope (%)	2.1	Yes	DWS Length (in)	24.0
Yes	Landing X Slope (%)	1.9	Yes	DWS Full Width?	Yes
N/A	Landing Curb? (Y/N)	N/A	Yes	DWS Offset LT (in)	2.0
N/A	Shared Landing?	No	Yes	DWS Offset RT (in)	2.0
Yes	Gutter Ponding?	No	Yes	Gutter Slope (%)	0.3
Yes	Gutter Lip Ht (in)	0.0	Yes	Gutter X Slope (%)	0.9
N/A	Painted X Walk1?	Yes		Road Slope (%)	2.1
	X Walk 1 Direction	To NW		Road X Slope (%)	1.0
	X Walk 1 Width (in)	144.0		Clear Space?	Yes

X Walk 1 Slope (%)	2.1	N/A	Clear Space to XWalk (in)	N/A
	X Walk 1 X Slope (%)	1.0	Yes	Storm Grate/Utility Hazard?	No
Yes	Ramp inside XWalk1?	Yes		Storm Grate/Utility Type	
Yes	Any Obstructions?	No			N/A
	Obstruction Type		Yes	Surface Condition? (G/P)	Good
			N/A	Curb Slope (%)	8.7

Possible Solutions:

Remove & Replace Entire Ramp.
