Access Compliance Report

Public Rights-of-Way

(Curb Ramps)

Intersection ID: 18800	Main Street: PARK_RD	Cross Street: SENECA_PL	Location: NW
ADA ID: EB47866EAC02	Ramp Type: PerpDiag	Initial Pass/Fail: Fail	Overall Compliance: No
		Severity Score: 12.5

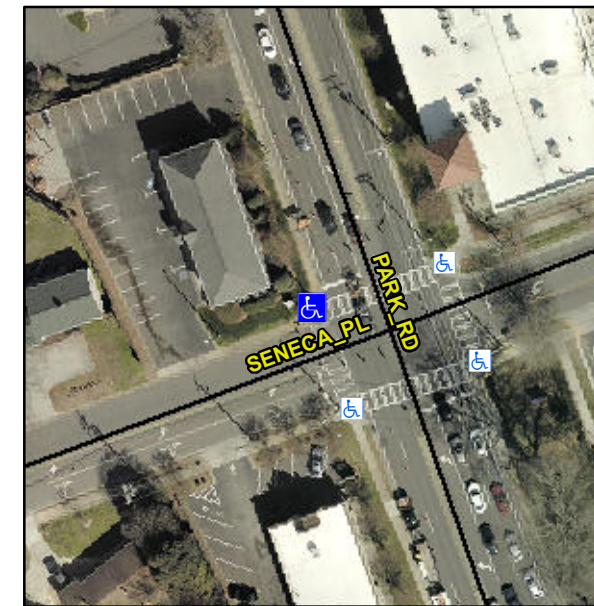
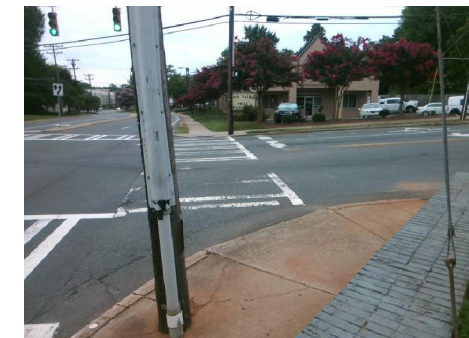
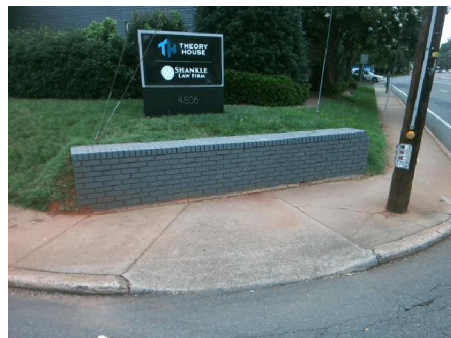
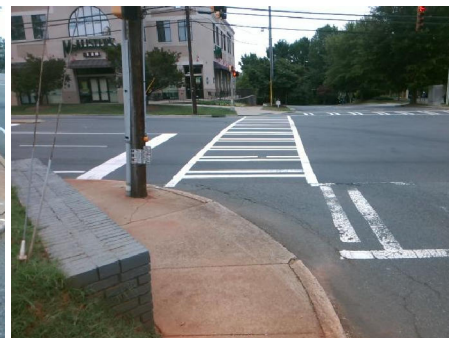
Not Found, R304.5.3

Compliance	Description	Data	Compliance	Description	Data
N/A	Ramp Length (in)	85.0	Yes	Ramp Slope (%)	7.2
Yes	Ramp Width (in)	51.0	No	Ramp XSlope (%)	5.9
N/A	Flare Type LT	N/A	N/A	Flare Type RT	N/A
N/A	Flare Slope LT (%)	N/A	N/A	Flare Slope RT (%)	N/A
N/A	Flare Traversable LT?	N/A	N/A	Flare Traversable RT?	N/A
N/A	Landing Length (in)	N/A	N/A	DWS Provided?	N/A
N/A	Landing Width (in)	N/A	N/A	DWS Contrast?	N/A
N/A	Landing Slope (%)	N/A	N/A	DWS Length (in)	N/A
N/A	Landing X Slope (%)	N/A	N/A	DWS Full Width?	N/A
N/A	Landing Curb? (Y/N)	N/A	N/A	DWS Offset (in)	N/A
N/A	Shared Landing?	N/A			
N/A	Gutter Ponding?	N/A	N/A	Gutter Slope (%)	N/A
N/A	Gutter Lip Ht (in)	N/A	N/A	Gutter X Slope (%)	N/A
N/A	Painted X Walk1?	Yes	N/A	Painted X Walk2?	Yes
	X Walk 1 Direction	To S		X Walk 2 Direction	To E
N/A	X Walk 1 Width (in)	112.0	N/A	X Walk 2 Width (in)	110.0
	X Walk 1 Slope (%)	2.0		X Walk 2 Slope (%)	1.2
	X Walk 1 X Slope (%)	0.4		X Walk 2 X Slope (%)	0.6

N/A	Ramp inside XWalk1?	Yes	N/A	Ramp inside XWalk2?	Yes
	Road Slope (%)	1.5	N/A	Clear Space?	N/A
	Road X Slope (%)	0.9	N/A	Clear Space to XWalk (in)	N/A
N/A	Any Obstructions?	N/A	N/A	Storm Grate/Utility Hazard?	N/A
	Obstruction Type			Storm Grate/Utility Type	
		N/A			N/A
		Yes		Surface Condition? (G/P)	Good

Remove & Replace Curb Ramp With Two New Directional Ramps or Equivalent.

Total Cost: \$ 3200.00
