Access Compliance Report

(Curb Ramps)

Intersection ID: 15762	Main Street: HOPEDALE_AV	Cross Street: QUEENS_RD	Location: NW
ADA ID: EB49E84285B6	Ramp Type: Perp	Initial Pass/Fail: Fail	Overall Compliance: No
		Severity Score: 25

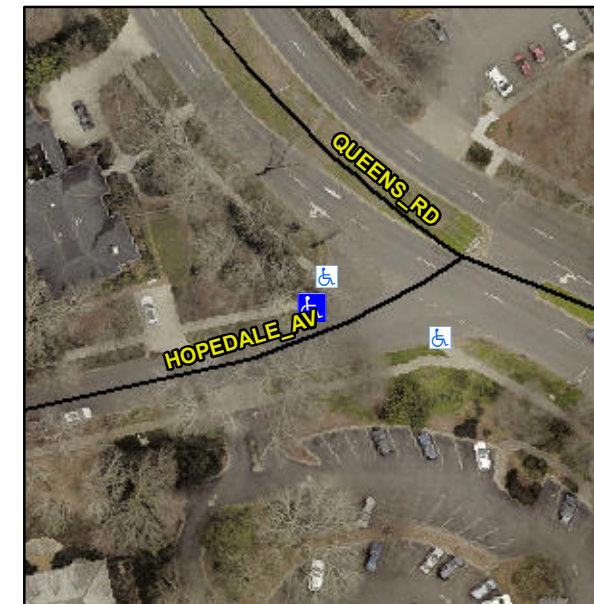
Not Found, R304.2.2, R304.5.3

Compliance	Description	Data	Compliance	Description	Data
N/A	Ramp Length (in)	36.0	No	Ramp Slope (%)	10.9
Yes	Ramp Width (in)	48.0	No	Ramp XSlope (%)	6.3
N/A	Flare Type LT	N/A	N/A	Flare Type RT	N/A
N/A	Flare Slope LT (%)	N/A	N/A	Flare Slope RT (%)	N/A
N/A	Flare Traversable LT?	N/A	N/A	Flare Traversable RT?	N/A
N/A	Landing Length (in)	N/A	N/A	DWS Provided?	N/A
N/A	Landing Width (in)	N/A	N/A	DWS Contrast?	N/A
N/A	Landing Slope (%)	N/A	N/A	DWS Length (in)	N/A
N/A	Landing X Slope (%)	N/A	N/A	DWS Full Width?	N/A
N/A	Landing Curb? (Y/N)	N/A	N/A	DWS Offset (in)	N/A
N/A	Shared Landing?	N/A			
N/A	Gutter Ponding?	N/A	N/A	Gutter Slope (%)	N/A
N/A	Gutter Lip Ht (in)	N/A	N/A	Gutter X Slope (%)	N/A
N/A	Painted X Walk1?	No	N/A	Painted X Walk2?	N/A
	X Walk 1 Direction	To SE		X Walk 2 Direction	N/A
N/A	X Walk 1 Width (in)	N/A	N/A	X Walk 2 Width (in)	N/A
	X Walk 1 Slope (%)	4.8		X Walk 2 Slope (%)	N/A
	X Walk 1 X Slope (%)	4.1		X Walk 2 X Slope (%)	N/A

Remove & Replace Entire Ramp.
