Access Compliance Report Public Rights-of-Way (Curb Ramps)

Intersection ID: 3767 Main Street: CLAIBORNE_WOODS_RD Cross Street: WOODCOCK_LN Location: SE

ADA ID: EB52CA00B9B2 Ramp Type: Perp Initial Pass/Fail: Fail Overall Compliance: No Severity Score: 42.5

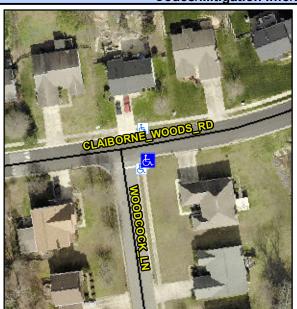
a55/F	ali. Fali Overali v	Compilan	ice. N	o Severity Score.	42.	
Field Measurements/Component Compliance						
Comp	liance Description	Data	Comp	liance Description	Data	
N/A	Ramp Length (in)	96.0	Yes	Ramp Slope (%)	7.1	
No	Ramp Width (in)	32.0	No	Ramp XSlope (%)	7.1	
N/A	Flare Type LT	N/A	N/A	Flare Type RT	N/A	
N/A	Flare Slope LT (%)	N/A	N/A	Flare Slope RT (%)	N/A	
N/A	Flare Traversable LT?	N/A	N/A	Flare Traversable RT?	N/A	
N/A	Landing Length (in)	N/A	N/A	DWS Provided?	N/A	
N/A	Landing Width (in)	N/A	N/A	DWS Contrast?	N/A	
N/A	Landing Slope (%)	N/A	N/A	DWS Length (in)	N/A	
N/A	Landing X Slope (%)	N/A	N/A	DWS Full Width?	N/A	
N/A	Landing Curb? (Y/N)	N/A	N/A	DWS Offset (in)	N/A	
N/A	Shared Landing?	N/A				
N/A	Gutter Ponding?	N/A	N/A	Gutter Slope (%)	N/A	
N/A	Gutter Lip Ht (in)	N/A	N/A	Gutter X Slope (%)	N/A	
N/A	Painted X Walk1?	No	N/A	Painted X Walk2?	N/A	
	X Walk 1 Direction	To N		X Walk 2 Direction	N/A

N/A	X Walk 1 Width (in)	N/A	N/A	X Walk 2 Width (in)	N/A	
	X Walk 1 Slope (%)	2.0		X Walk 2 Slope (%)	N/A	
	X Walk 1 X Slope (%)	4.1		X Walk 2 X Slope (%)	N/A	
N/A	Ramp inside XWalk1?	N/A	N/A	Ramp inside XWalk2?	N/A	
	Road Slope (%)	N/A	N/A	Clear Space?	N/A	
	Road X Slope (%)	N/A	N/A	Clear Space to XWalk (in)	N/A	
N/A	Any Obstructions?	N/A	N/A	Storm Grate/Utility Hazard?	N/A	
	Obstruction Type		l	Storm Grate/Utility Type		
		N/A			N/A	
			Yes	Surface Condition? (G/P)	Good

Possible Solution	
Possible Solutions:	Com
Remove & Replace Entire Ramp.	N/A
	No
	N/A
	N/A
	N/A
	N/A
Surveyor Notes:	N/A
N/A	N/A
	N/A
	N/A
	N/A
PROW/ADA:	N/A
R304.5.1, R304.5.3	N/A
,	N/A
	N/A
	N/A
