# Access Compliance Report

## Public Rights-of-Way

### (Curb Ramps)

Intersection ID: 54468	Main Street: COLLINGHAM_DR	Cross Street: STEELE_CREEK_RD	Location: SW
ADA ID: EB56E0A30DF4	Ramp Type: Perp	Initial Pass/Fail: Pass	Overall Compliance: No
Severity Score: 15			
Codes/Mitigation Info/Possible Solution		Field Measurements/Component Compliance

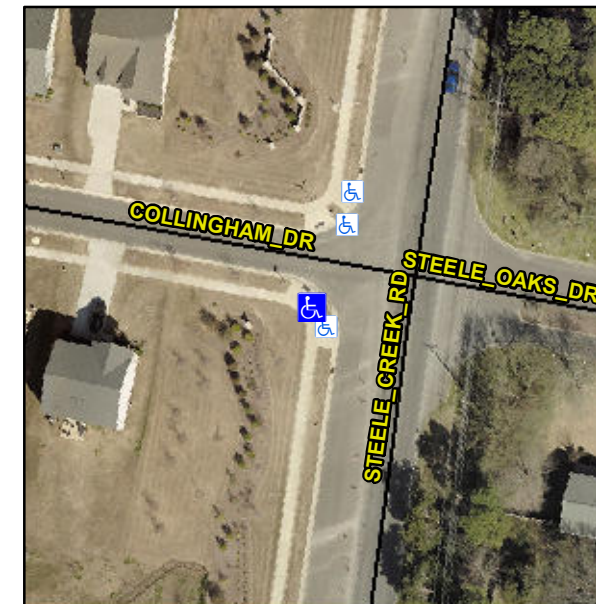
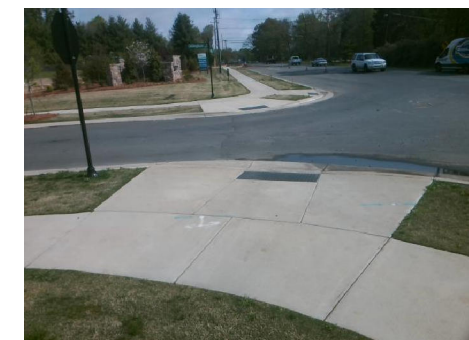
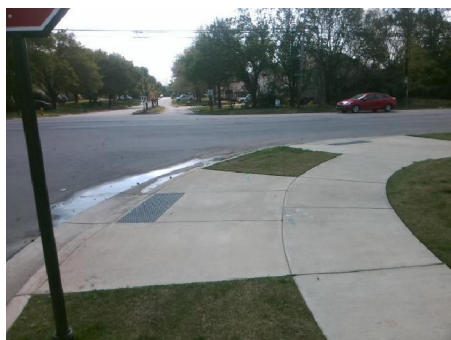
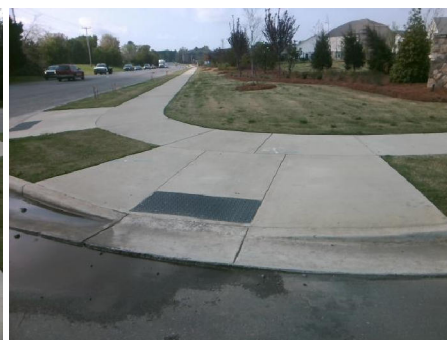
Compliance	Description	Data	Compliance	Description	Data
N/A	Ramp Length (in)	101.0	Yes	Ramp Slope (%)	6.3
Yes	Ramp Width (in)	58.0	Yes	Ramp XSlope (%)	0.6
N/A	Flare Type LT	Sloped	N/A	Flare Type RT	N/A
N/A	Flare Slope LT (%)	6.1	Yes	Flare Slope RT (%)	4.7
N/A	Flare Traversable LT?	Yes	N/A	Flare Traversable RT?	Yes
Yes	Landing Length (in)	61.0	Yes	DWS Provided?	Yes
Yes	Landing Width (in)	58.0	Yes	DWS Contrast?	Yes
No	Landing Slope (%)	2.6	Yes	DWS Length (in)	24.0
Yes	Landing X Slope (%)	0.2	Yes	DWS Full Width?	Yes
N/A	Landing Curb? (Y/N)	No	No	DWS Offset (in)	5.0
N/A	Shared Landing?	No			
Yes	Gutter Ponding?	No	Yes	Gutter Slope (%)	4.5
No	Gutter Lip Ht (in)	1.5	Yes	Gutter X Slope (%)	0.5
N/A	Painted X Walk1?	No	N/A	Painted X Walk2?	N/A
	X Walk 1 Direction	To NE		X Walk 2 Direction	N/A
N/A	X Walk 1 Width (in)	N/A	N/A	X Walk 2 Width (in)	N/A
	X Walk 1 Slope (%)	3.3		X Walk 2 Slope (%)	N/A
	X Walk 1 X Slope (%)	0.9		X Walk 2 X Slope (%)	N/A

N/A	Ramp inside XWalk1?	N/A	N/A	Ramp inside XWalk2?	N/A
	Road Slope (%)	N/A	N/A	Clear Space?	Yes
	Road X Slope (%)	N/A	N/A	Clear Space to XWalk (in)	N/A
Yes	Any Obstructions?	No	Yes	Storm Grate/Utility Hazard?	No
	Obstruction Type			Storm Grate/Utility Type	
		N/A			N/A
			Yes	Surface Condition? (G/P)	Good

Possible Solutions:

**Remove & Replace Entire Ramp.**
