Access Compliance Report

Public Rights-of-Way

(Curb Ramps)

Intersection ID: 7616	Main Street: GEORGETOWN_DR	Cross Street: SPRING_GARDEN_LN	Location: NW
ADA ID: EB588D1A4190	Ramp Type: BlendTrans1	Initial Pass/Fail: Fail	Overall Compliance: No
		Severity Score: 8.75

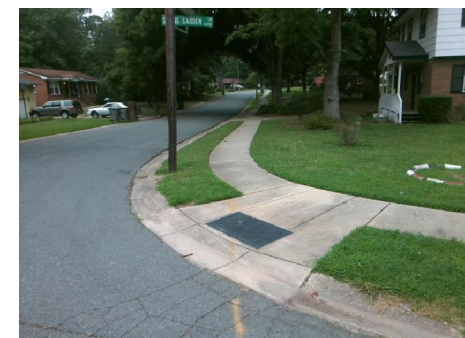
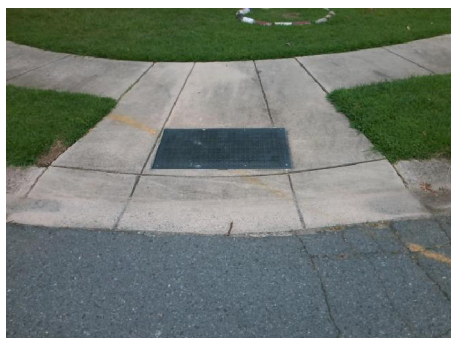
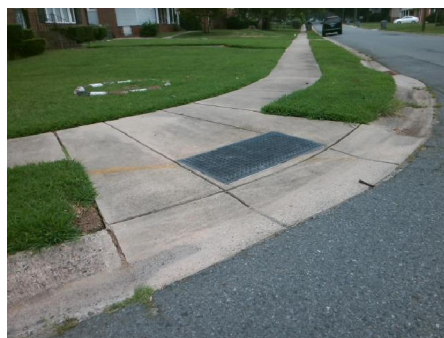
Compliance	Description	Data	Compliance	Description	Data
N/A	Ramp Length (in)	47.0	Yes	BlendTrans Slope (%)	4.4
No	Ramp Width (in)	38.0	Yes	BlendTrans XSlope (%)	0.5
N/A	Flare Type LT	N/A	N/A	Flare Type RT	N/A
N/A	Flare Slope LT (%)	N/A	N/A	Flare Slope RT (%)	N/A
N/A	Flare Traversable LT?	N/A	N/A	Flare Traversable RT?	N/A
N/A	Landing Length (in)	N/A	N/A	DWS Provided?	N/A
N/A	Landing Width (in)	N/A	N/A	DWS Contrast?	N/A
N/A	Landing Slope (%)	N/A	N/A	DWS Length (in)	N/A
N/A	Landing X Slope (%)	N/A	N/A	DWS Full Width?	N/A
N/A	Landing Curb? (Y/N)	N/A	N/A	DWS Offset (in)	N/A
N/A	Shared Landing?	N/A			
N/A	Gutter Ponding?	N/A	N/A	Gutter Slope (%)	N/A
N/A	Gutter Lip Ht (in)	N/A	N/A	Gutter X Slope (%)	N/A
N/A	Painted X Walk1?	No	N/A	Painted X Walk2?	No
	X Walk 1 Direction	To S		X Walk 2 Direction	To E
	X Walk 1 Width (in)	N/A		X Walk 2 Width (in)	N/A
	X Walk 1 Slope (%)	2.5		X Walk 2 Slope (%)	5.1
	X Walk 1 X Slope (%)	3.0		X Walk 2 X Slope (%)	3.0

N/A	Ramp inside XWalk1?	N/A	N/A	Ramp inside XWalk2?	N/A
	Road Slope (%)	0.1		Clear Space?	N/A
	Road X Slope (%)	5.0	N/A	Clear Space to XWalk (in)	N/A
N/A	Any Obstructions?	N/A	N/A	Storm Grate/Utility Hazard?	N/A
	Obstruction Type			Storm Grate/Utility Type	
		N/A			N/A
			Yes	Surface Condition? (G/P)	Good
			No	Curb Slope (%)	32.6

Remove & Replace Curb Ramp With Two New Directional Ramps or Equivalent.
