Access Compliance Report

Public Rights-of-Way

(Curb Ramps)

Intersection ID: 9260	Main Street: MILES_CT	Cross Street: MULBERRY_AV	Location: SE
ADA ID: EB6ED07A49B8	Ramp Type: Perp	Initial Pass/Fail: Fail	Overall Compliance: No
Severity Score: 8.75			
Codes/Mitigation Info/Possible Solution		Field Measurements/Component Compliance

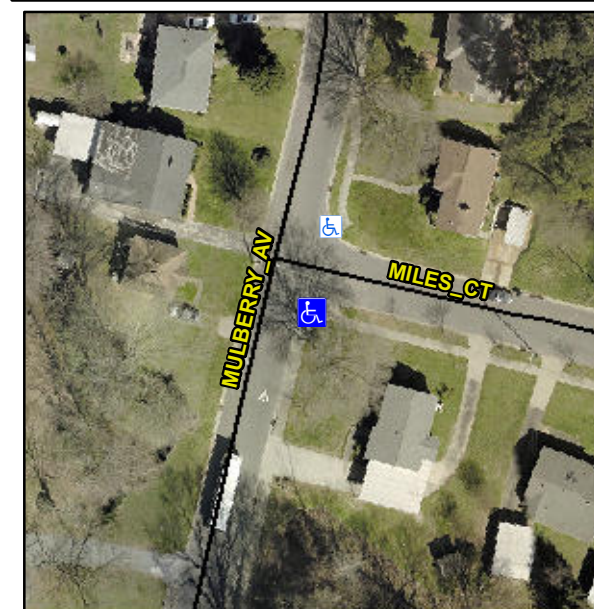
Not Found, R304.5.1

Compliance	Description	Data	Compliance	Description	Data
N/A	Ramp Length (in)	28.0	Yes	Ramp Slope (%)	6.5
No	Ramp Width (in)	47.0	Yes	Ramp XSlope (%)	0.7
N/A	Flare Type LT	N/A	N/A	Flare Type RT	N/A
N/A	Flare Slope LT (%)	N/A	N/A	Flare Slope RT (%)	N/A
N/A	Flare Traversable LT?	N/A	N/A	Flare Traversable RT?	N/A
N/A	Landing Length (in)	N/A	N/A	DWS Provided?	N/A
N/A	Landing Width (in)	N/A	N/A	DWS Contrast?	N/A
N/A	Landing Slope (%)	N/A	N/A	DWS Length (in)	N/A
N/A	Landing X Slope (%)	N/A	N/A	DWS Full Width?	N/A
N/A	Landing Curb? (Y/N)	N/A	N/A	DWS Offset (in)	N/A
N/A	Shared Landing?	N/A			
N/A	Gutter Ponding?	N/A	N/A	Gutter Slope (%)	N/A
N/A	Gutter Lip Ht (in)	N/A	N/A	Gutter X Slope (%)	N/A
N/A	Painted X Walk1?	No	N/A	Painted X Walk2?	N/A
	X Walk 1 Direction	To N		X Walk 2 Direction	N/A
N/A	X Walk 1 Width (in)	N/A	N/A	X Walk 2 Width (in)	N/A
	X Walk 1 Slope (%)	5.6		X Walk 2 Slope (%)	N/A
	X Walk 1 X Slope (%)	4.5		X Walk 2 X Slope (%)	N/A

N/A	Ramp inside XWalk1?	N/A	N/A	Ramp inside XWalk2?	N/A
	Road Slope (%)	N/A	N/A	Clear Space?	N/A
	Road X Slope (%)	N/A	N/A	Clear Space to XWalk (in)	N/A
N/A	Any Obstructions?	N/A	N/A	Storm Grate/Utility Hazard?	N/A
	Obstruction Type			Storm Grate/Utility Type	
		N/A			N/A
			Yes	Surface Condition? (G/P)	Good

Remove & Replace Entire Ramp.
