Access Compliance Report

Public Rights-of-Way

(Curb Ramps)

Intersection ID: 50103	Main Street: SUNFLOWER_VALLEY_DR	Cross Street: DOVE_MEADOW_DR	Location: SW
ADA ID: EB7225B19484	Ramp Type: BlendTrans1	Initial Pass/Fail: Fail	Overall Compliance: No
Severity Score: 10			
Codes/Mitigation Info/Possible Solution		Field Measurements/Component Compliance

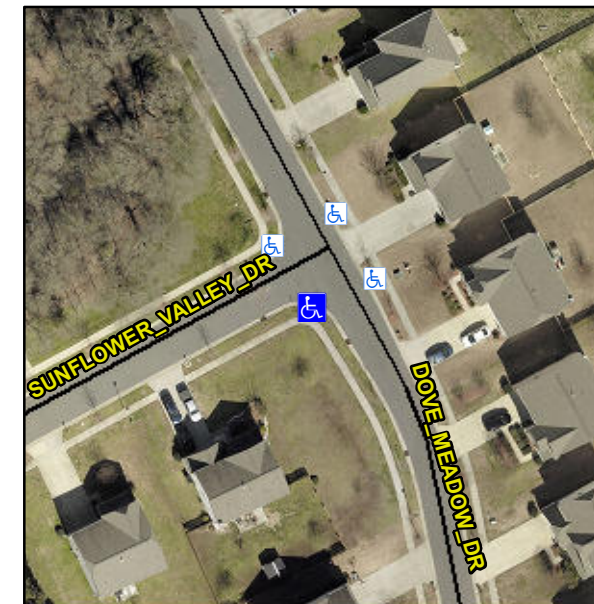
Not Found, R304.5.1, R304.5.3

Compliance	Description	Data	Compliance	Description	Data
N/A	Ramp Length (in)	69.0	Yes	BlendTrans Slope (%)	2.8
No	Ramp Width (in)	46.5	No	BlendTrans XSlope (%)	2.3
N/A	Flare Type LT	N/A	N/A	Flare Type RT	N/A
N/A	Flare Slope LT (%)	N/A	N/A	Flare Slope RT (%)	N/A
N/A	Flare Traversable LT?	N/A	N/A	Flare Traversable RT?	N/A
N/A	Landing Length (in)	N/A	N/A	DWS Provided?	N/A
N/A	Landing Width (in)	N/A	N/A	DWS Contrast?	N/A
N/A	Landing Slope (%)	N/A	N/A	DWS Length (in)	N/A
N/A	Landing X Slope (%)	N/A	N/A	DWS Full Width?	N/A
N/A	Landing Curb? (Y/N)	N/A	N/A	DWS Offset (in)	N/A
N/A	Shared Landing?	N/A			
N/A	Gutter Ponding?	N/A	N/A	Gutter Slope (%)	N/A
N/A	Gutter Lip Ht (in)	N/A	N/A	Gutter X Slope (%)	N/A
N/A	Painted X Walk1?	No	N/A	Painted X Walk2?	No
	X Walk 1 Direction	To NE		X Walk 2 Direction	To NW
	X Walk 1 Width (in)	N/A		X Walk 2 Width (in)	N/A
	X Walk 1 Slope (%)	2.6		X Walk 2 Slope (%)	2.7
	X Walk 1 X Slope (%)	0.5		X Walk 2 X Slope (%)	2.9

N/A	Ramp inside XWalk1?	N/A	N/A	Ramp inside XWalk2?	N/A
	Road Slope (%)	0.1		Clear Space?	N/A
	Road X Slope (%)	3.2	N/A	Clear Space to XWalk (in)	N/A
N/A	Any Obstructions?	N/A	N/A	Storm Grate/Utility Hazard?	N/A
	Obstruction Type			Storm Grate/Utility Type	
		N/A			N/A
			Yes	Surface Condition? (G/P)	Good
			No	Curb Slope (%)	7.7

Remove & Replace Curb Ramp With Two New Directional Ramps or Equivalent.
