Access Compliance Report

Public Rights-of-Way

(Curb Ramps)

Intersection ID: 11911	Main Street: W_7TH_ST	Cross Street: N_CHURCH_ST	Location: E
ADA ID: EB79E38C7364	Ramp Type: PerpDiag	Initial Pass/Fail: Pass	Overall Compliance: No
Severity Score: 5			
Codes/Mitigation Info/Possible Solution		Field Measurements/Component Compliance

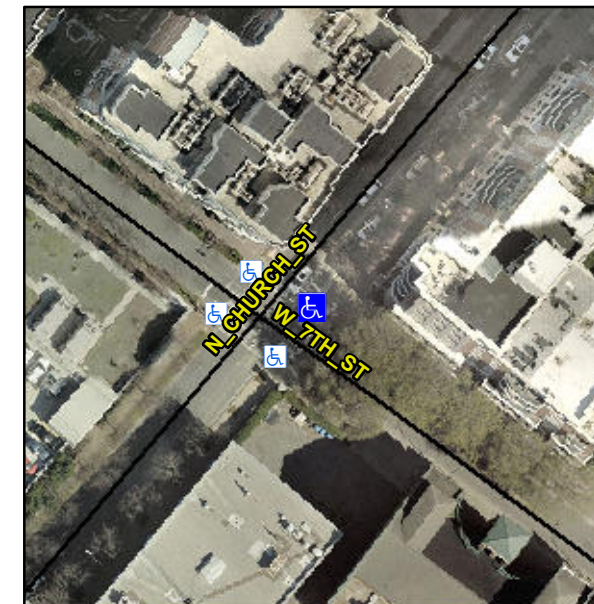
Compliance	Description	Data	Compliance	Description	Data
N/A	Ramp Length (in)	90.0	Yes	Ramp Slope (%)	5.2
Yes	Ramp Width (in)	58.0	Yes	Ramp XSlope (%)	1.2
N/A	Flare Type LT	Sloped	No	Flare Type RT	N/A
N/A	Flare Slope LT (%)	3.4	N/A	Flare Slope RT (%)	N/A
N/A	Flare Traversable LT?	Yes	N/A	Flare Traversable RT?	No
Yes	Landing Length (in)	60.0	Yes	DWS Provided?	Yes
Yes	Landing Width (in)	50.0	Yes	DWS Contrast?	Yes
No	Landing Slope (%)	2.4	Yes	DWS Length (in)	24.0
No	Landing X Slope (%)	3.5	Yes	DWS Full Width?	Yes
N/A	Landing Curb? (Y/N)	No	Yes	DWS Offset (in)	1.5
N/A	Shared Landing?	No			
Yes	Gutter Ponding?	No	Yes	Gutter Slope (%)	1.7
Yes	Gutter Lip Ht (in)	0.0	Yes	Gutter X Slope (%)	0.4
N/A	Painted X Walk1?	Yes	N/A	Painted X Walk2?	Yes
	X Walk 1 Direction	To NW		X Walk 2 Direction	To SW
N/A	X Walk 1 Width (in)	88.0	N/A	X Walk 2 Width (in)	107.0
	X Walk 1 Slope (%)	1.1		X Walk 2 Slope (%)	5.4
	X Walk 1 X Slope (%)	3.6		X Walk 2 X Slope (%)	0.7

Yes	Ramp inside XWalk1?	Yes	Yes	Ramp inside XWalk2?	Yes
	Road Slope (%)	1.7	N/A	Clear Space?	Yes
	Road X Slope (%)	0.9	Yes	Clear Space to XWalk (in)	50.0
Yes	Any Obstructions?	No	Yes	Storm Grate/Utility Hazard?	No
	Obstruction Type			Storm Grate/Utility Type	
		N/A			N/A
			Yes	Surface Condition? (G/P)	Good

Possible Solutions:

Remove & Replace Curb Ramp With Two New Directional Ramps or Equivalent.
