# Access Compliance Report

## Public Rights-of-Way

### (Curb Ramps)

Intersection ID: 15502	Main Street: YORKMONT_RD	Cross Street: WEST_BV	Location: SE
ADA ID: EB7EA524B2EF	Ramp Type: PerpDiag	Initial Pass/Fail: Fail	Overall Compliance: No
		Severity Score: 12.5

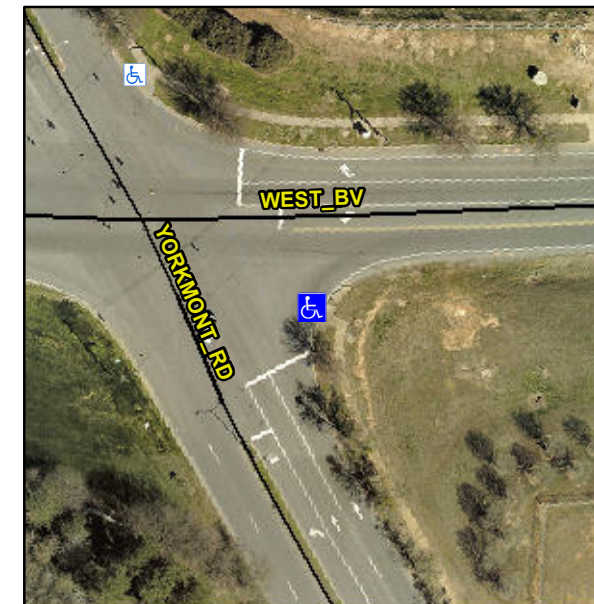
**Not Found, R304.2.2**

Compliance	Description	Data	Compliance	Description	Data
N/A	Ramp Length (in)	72.0	No	Ramp Slope (%)	8.7
Yes	Ramp Width (in)	48.0	Yes	Ramp XSlope (%)	0.7
N/A	Flare Type LT	N/A	N/A	Flare Type RT	N/A
N/A	Flare Slope LT (%)	N/A	N/A	Flare Slope RT (%)	N/A
N/A	Flare Traversable LT?	N/A	N/A	Flare Traversable RT?	N/A
N/A	Landing Length (in)	N/A	N/A	DWS Provided?	N/A
N/A	Landing Width (in)	N/A	N/A	DWS Contrast?	N/A
N/A	Landing Slope (%)	N/A	N/A	DWS Length (in)	N/A
N/A	Landing X Slope (%)	N/A	N/A	DWS Full Width?	N/A
N/A	Landing Curb? (Y/N)	N/A	N/A	DWS Offset (in)	N/A
N/A	Shared Landing?	N/A			
N/A	Gutter Ponding?	N/A	N/A	Gutter Slope (%)	N/A
N/A	Gutter Lip Ht (in)	N/A	N/A	Gutter X Slope (%)	N/A
N/A	Painted X Walk1?	No	N/A	Painted X Walk2?	No
	X Walk 1 Direction	To N		X Walk 2 Direction	To NW
N/A	X Walk 1 Width (in)	N/A	N/A	X Walk 2 Width (in)	N/A
	X Walk 1 Slope (%)	2.5		X Walk 2 Slope (%)	0.2
	X Walk 1 X Slope (%)	1.2		X Walk 2 X Slope (%)	1.7

N/A	Ramp inside XWalk1?	N/A	N/A	Ramp inside XWalk2?	N/A
	Road Slope (%)	0.8	N/A	Clear Space?	N/A
	Road X Slope (%)	1.9	N/A	Clear Space to XWalk (in)	N/A
N/A	Any Obstructions?	N/A	N/A	Storm Grate/Utility Hazard?	N/A
	Obstruction Type			Storm Grate/Utility Type	
		N/A			N/A
			Yes	Surface Condition? (G/P)	Good

**Remove & Replace Curb Ramp With Two New Directional Ramps or Equivalent.**

Total Cost: \$ 3200.00
