Access Compliance Report

Public Rights-of-Way

(Curb Ramps)

Intersection ID: 11739	Main Street: W_9TH_ST	Cross Street: N_CHURCH_ST	Location: E
ADA ID: EB87715309CF	Ramp Type: PerpDiag	Initial Pass/Fail: Fail	Overall Compliance: No
Severity Score: 12.5			
Codes/Mitigation Info/Possible Solution		Field Measurements/Component Compliance

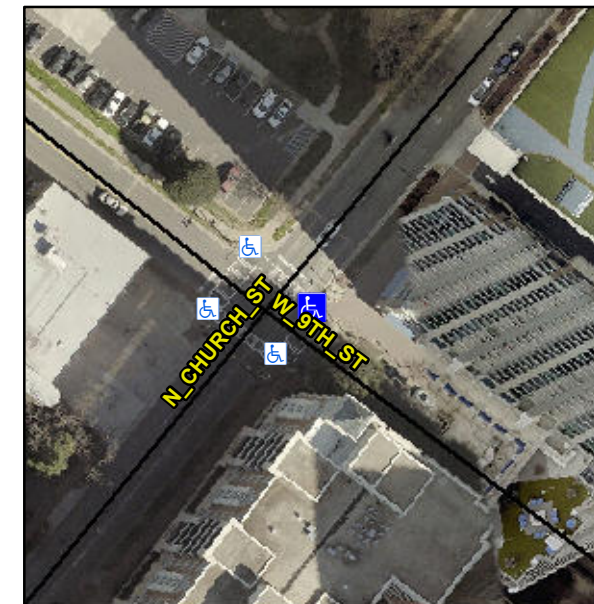
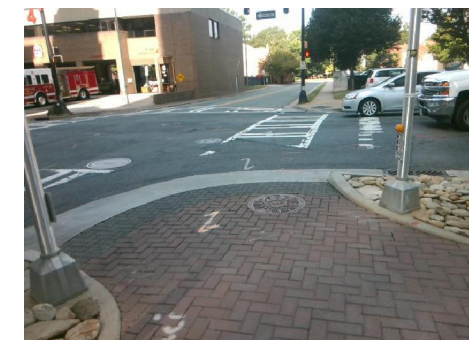
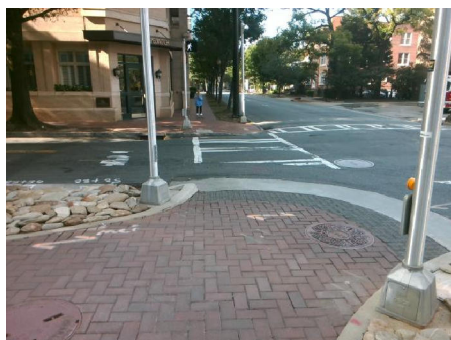
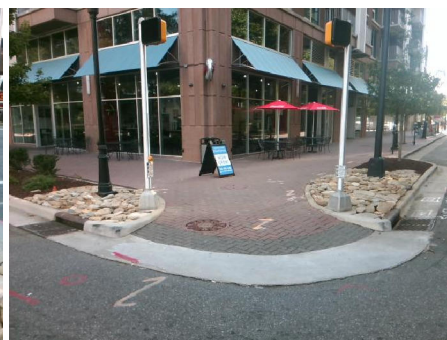
Compliance	Description	Data	Compliance	Description	Data
N/A	Ramp Length (in)	92.0	Yes	Ramp Slope (%)	5.6
Yes	Ramp Width (in)	119.0	No	Ramp XSlope (%)	6.1
N/A	Flare Type LT	N/A	N/A	Flare Type RT	N/A
N/A	Flare Slope LT (%)	N/A	N/A	Flare Slope RT (%)	N/A
N/A	Flare Traversable LT?	N/A	N/A	Flare Traversable RT?	N/A
N/A	Landing Length (in)	N/A	N/A	DWS Provided?	N/A
N/A	Landing Width (in)	N/A	N/A	DWS Contrast?	N/A
N/A	Landing Slope (%)	N/A	N/A	DWS Length (in)	N/A
N/A	Landing X Slope (%)	N/A	N/A	DWS Full Width?	N/A
N/A	Landing Curb? (Y/N)	N/A	N/A	DWS Offset (in)	N/A
N/A	Shared Landing?	N/A			
N/A	Gutter Ponding?	N/A	N/A	Gutter Slope (%)	N/A
N/A	Gutter Lip Ht (in)	N/A	N/A	Gutter X Slope (%)	N/A
N/A	Painted X Walk1?	Yes	N/A	Painted X Walk2?	Yes
	X Walk 1 Direction	To NW		X Walk 2 Direction	To SW
N/A	X Walk 1 Width (in)	72.0	N/A	X Walk 2 Width (in)	109.0
	X Walk 1 Slope (%)	3.7		X Walk 2 Slope (%)	0.3
	X Walk 1 X Slope (%)	0.5		X Walk 2 X Slope (%)	2.0

N/A	Ramp inside XWalk1?	Yes	N/A	Ramp inside XWalk2?	Yes
	Road Slope (%)	0.4	N/A	Clear Space?	N/A
	Road X Slope (%)	5.8	N/A	Clear Space to XWalk (in)	N/A
N/A	Any Obstructions?	N/A	N/A	Storm Grate/Utility Hazard?	N/A
	Obstruction Type			Storm Grate/Utility Type	
		N/A			N/A
		Yes		Surface Condition? (G/P)	Good

Possible Solutions:

Remove & Replace Curb Ramp With Two New Directional Ramps or Equivalent.

R304.5.3
