Intersection ID: 3262	Main Street: HIGHCROFT_LN	Cross Street: SUFFIELD_CT	Location:	NW
ADA ID: EB95C0DF9E0D	Ramp Type: BlendTrans1	Initial Pass/Fail: Fail	Overall Compliance: No	Severity Score: 12.5

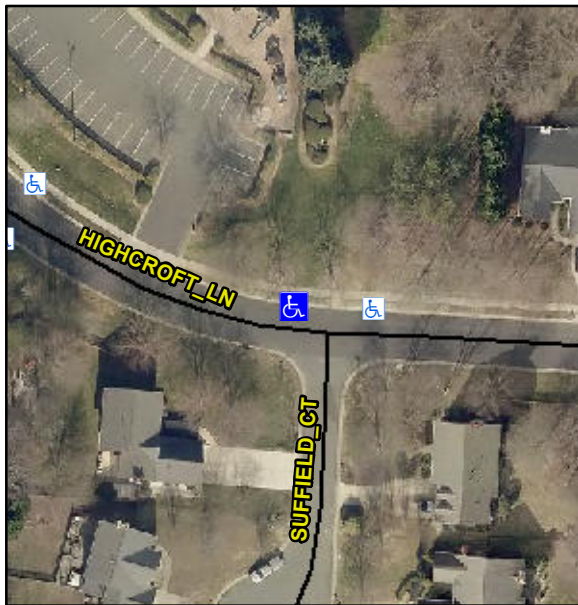
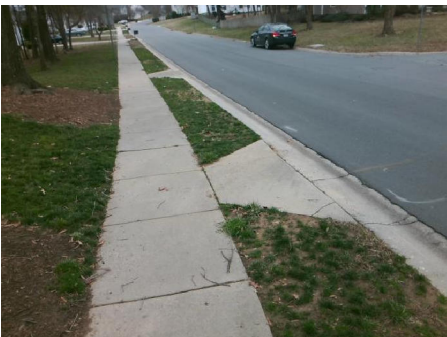
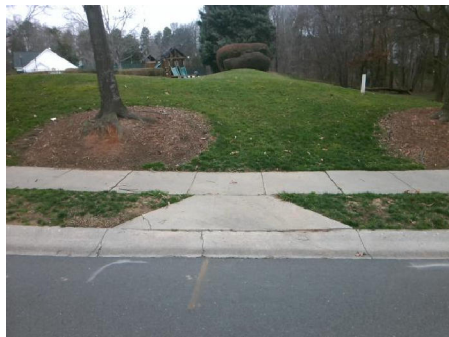
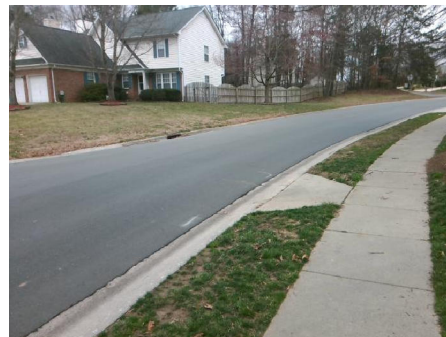
Not Found, R304.5.3

Compliance	Description	Data	Compliance	Description	Data
N/A	Ramp Length (in)	47.0	Yes	BlendTrans Slope (%)	3.7
Yes	Ramp Width (in)	48.0	No	BlendTrans XSlope (%)	5.3
N/A	Flare Type LT	N/A	N/A	Flare Type RT	N/A
N/A	Flare Slope LT (%)	N/A	N/A	Flare Slope RT (%)	N/A
N/A	Flare Traversable LT?	N/A	N/A	Flare Traversable RT?	N/A
N/A	Landing Length (in)	N/A	N/A	DWS Provided?	N/A
N/A	Landing Width (in)	N/A	N/A	DWS Contrast?	N/A
N/A	Landing Slope (%)	N/A	N/A	DWS Length (in)	N/A
N/A	Landing X Slope (%)	N/A	N/A	DWS Full Width?	N/A
N/A	Landing Curb? (Y/N)	N/A	N/A	DWS Offset (in)	N/A
N/A	Shared Landing?	N/A			
N/A	Gutter Ponding?	N/A	N/A	Gutter Slope (%)	N/A
N/A	Gutter Lip Ht (in)	N/A	N/A	Gutter X Slope (%)	N/A
N/A	Painted X Walk1?	No	N/A	Painted X Walk2?	N/A
	X Walk 1 Direction	To S		X Walk 2 Direction	N/A
	X Walk 1 Width (in)	N/A		X Walk 2 Width (in)	N/A
	X Walk 1 Slope (%)	4.2		X Walk 2 Slope (%)	N/A
	X Walk 1 X Slope (%)	4.2		X Walk 2 X Slope (%)	N/A

N/A	Ramp inside XWalk1?	N/A	N/A	Ramp inside XWalk2?	N/A
	Road Slope (%)	4.2		Clear Space?	N/A
	Road X Slope (%)	4.2	N/A	Clear Space to XWalk (in)	N/A
N/A	Any Obstructions?	N/A	N/A	Storm Grate/Utility Hazard?	N/A
	Obstruction Type			Storm Grate/Utility Type	
		N/A			N/A
			Yes	Surface Condition? (G/P)	Good
			No	Curb Slope (%)	12.1

Remove & Replace Curb Ramp With Two New Directional Ramps or Equivalent.
