## Access Compliance Report Public Rights-of-Way (Curb Ramps)

Intersection ID: 28495 Main Street: TYVOLA\_CENTRE\_DR Cross Street: CAMERON\_WALK\_CT Location: SW

ADA ID: EB9C8AAD9175 Ramp Type: PerpDiag Initial Pass/Fail: Pass Overall Compliance: No Severity Score: 10.25

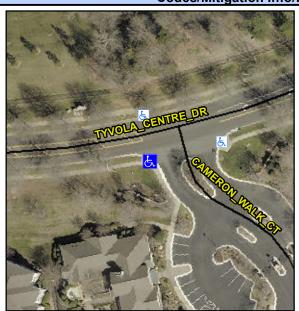
Compliance Description		Data	Compliance Description		Data
N/A	Ramp Length (in)	63.0	Yes	Ramp Slope (%)	6.2
Yes	Ramp Width (in)	60.0	No	Ramp XSlope (%)	2.9
N/A	Flare Type LT	Sloped	N/A	Flare Type RT	N/A
N/A	Flare Slope LT (%)	8.4	N/A	Flare Slope RT (%)	4.9
N/A	Flare Traversable LT?	Yes	N/A	Flare Traversable RT?	No
No	Landing Length (in)	30.0	No	DWS Provided?	No
Yes	Landing Width (in)	60.0	N/A	DWS Contrast?	No
No	Landing Slope (%)	3.1	N/A	DWS Length (in)	N/A
Yes	Landing X Slope (%)	0.9	N/A	DWS Full Width?	No
N/A	Landing Curb? (Y/N)	No	N/A	DWS Offset (in)	N/A
N/A	Shared Landing?	No			
Yes	Gutter Ponding?	No	Yes	Gutter Slope (%)	4.8
Yes	Gutter Lip Ht (in)	0.0	Yes	Gutter X Slope (%)	1.4
N/A	Painted X Walk1?	No	N/A	Painted X Walk2?	No
	X Walk 1 Direction	То Е		X Walk 2 Direction	To N
N/A	X Walk 1 Width (in)	N/A	N/A	X Walk 2 Width (in)	N/A
	X Walk 1 Slope (%)	3.8		X Walk 2 Slope (%)	3.1
	X Walk 1 X Slope (%)	1.6		X Walk 2 X Slope (%)	4.1

N/A	Ramp inside XWalk1?	N/A	N/A	Ramp inside XWalk2?	N/A
	Road Slope (%)	0.9	N/A	Clear Space?	Yes
	Road X Slope (%)	2.9	N/A	Clear Space to XWalk (in)	N/A
Yes	Any Obstructions?	No	Yes	Storm Grate/Utility Hazard?	No
	Obstruction Type			Storm Grate/Utility Type	
		N/A			N/A
			Yes	Surface Condition? (G/P)	Good

Remove & Replace Curb Ramp With Two New Directional Ramps or Equivalent.
