# Access Compliance Report

## Public Rights-of-Way

### (Curb Ramps)

Intersection ID: 10020730	Main Street: BEATTIES_FORD_RD	Cross Street: N/A	Location: SW
ADA ID: EBACFC9C22C2	Ramp Type: Para	Initial Pass/Fail: Fail	Overall Compliance: No
Severity Score: 12.5			
Codes/Mitigation Info/Possible Solution		Field Measurements/Component Compliance

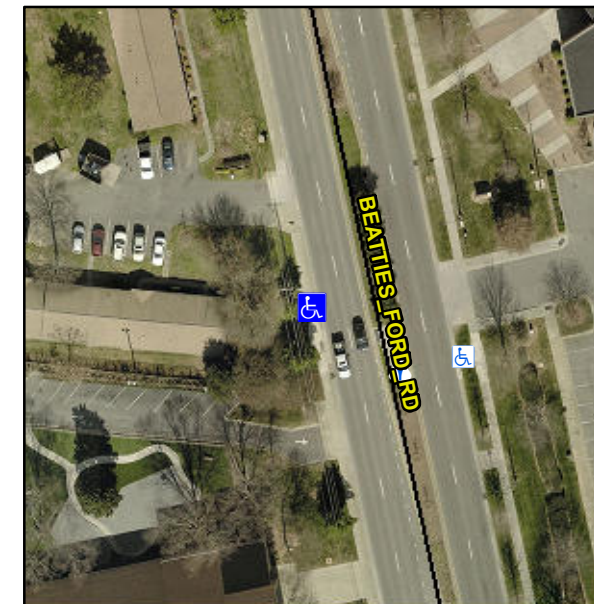
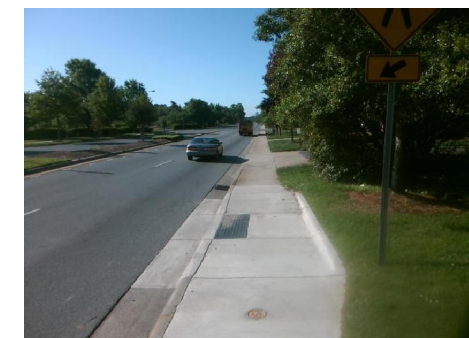
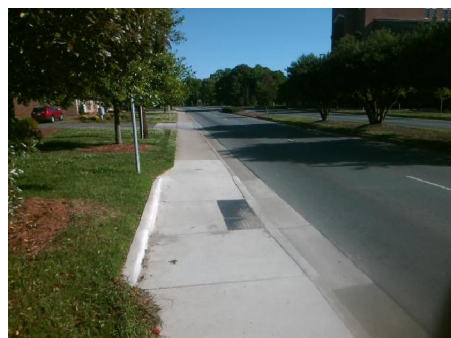
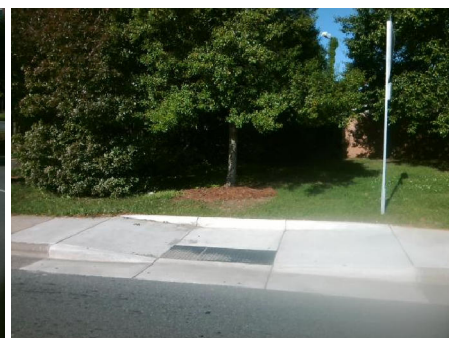
Compliance	Description	Data	Compliance	Description	Data
N/A	Ramp Length LT (in)	73.0	N/A	Ramp Length RT (in)	74.0
Yes	Ramp Width LT (in)	71.0	Yes	Ramp Width RT (in)	71.0
Yes	Ramp Slope LT (%)	8.0	No	Ramp Slope RT (%)	10.1
Yes	Ramp XSlope LT (%)	1.2	Yes	Ramp XSlope RT (%)	1.4
N/A	Landing Length (in)	N/A	N/A	DWS Provided?	N/A
N/A	Landing Width (in)	N/A	N/A	DWS Contrast?	N/A
N/A	Landing Slope (%)	N/A	N/A	DWS Length (in)	N/A
N/A	Landing X Slope (%)	N/A	N/A	DWS Full Width?	N/A
N/A	Landing Curb? (Y/N)	N/A	N/A	DWS Offset (in)	N/A
N/A	Shared Landing?	N/A			
N/A	Gutter Ponding?	N/A	N/A	Gutter Slope (%)	N/A
N/A	Gutter Lip Ht (in)	N/A	N/A	Gutter X Slope (%)	N/A
N/A	Painted X Walk1?	No	N/A	Painted X Walk2?	N/A
	X Walk 1 Direction	To NE		X Walk 2 Direction	N/A
N/A	X Walk 1 Width (in)	N/A	N/A	X Walk 2 Width (in)	N/A
	X Walk 1 Slope (%)	4.3		X Walk 2 Slope (%)	N/A
	X Walk 1 X Slope (%)	1.2		X Walk 2 X Slope (%)	N/A
N/A	Ramp inside XWalk1?	N/A	N/A	Ramp inside XWalk2?	N/A

Road Slope (%)	N/A	N/A	Clear Space?	N/A
	Road X Slope (%)	N/A	N/A	Clear Space to XWalk (in)	N/A
N/A	Any Obstructions?	N/A	N/A	Storm Grate/Utility Hazard?	N/A
	Obstruction Type			Storm Grate/Utility Type	
		N/A			N/A
			Yes	Surface Condition? (G/P)	Good
			N/A	Curb Slope (%)	6.8

**Remove & Replace Entire Ramp.**

**R304.3.2**
