# Access Compliance Report

## Public Rights-of-Way

### (Curb Ramps)

Intersection ID: 10036062	Main Street: RIVERGATE_PY	Cross Street: N/A	Location: W
ADA ID: EBB119FF8EA2	Ramp Type: Perp	Initial Pass/Fail: Fail	Overall Compliance: No
Codes/Mitigation Info/Possible Solution		Field Measurements/Component Compliance	
Severity Score: 13.75

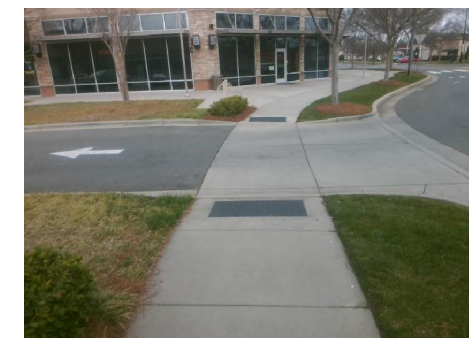
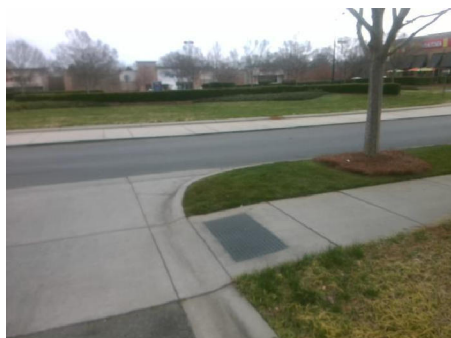
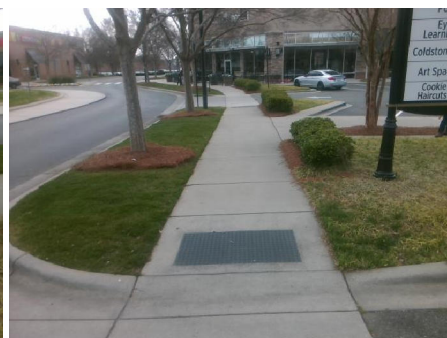
**Not Found, R304.2.2, R304.5.3**

Compliance	Description	Data	Compliance	Description	Data
N/A	Ramp Length (in)	46.5	No	Ramp Slope (%)	8.6
Yes	Ramp Width (in)	72.0	No	Ramp XSlope (%)	2.2
N/A	Flare Type LT	N/A	N/A	Flare Type RT	N/A
N/A	Flare Slope LT (%)	N/A	N/A	Flare Slope RT (%)	N/A
N/A	Flare Traversable LT?	N/A	N/A	Flare Traversable RT?	N/A
N/A	Landing Length (in)	N/A	N/A	DWS Provided?	N/A
N/A	Landing Width (in)	N/A	N/A	DWS Contrast?	N/A
N/A	Landing Slope (%)	N/A	N/A	DWS Length (in)	N/A
N/A	Landing X Slope (%)	N/A	N/A	DWS Full Width?	N/A
N/A	Landing Curb? (Y/N)	N/A	N/A	DWS Offset (in)	N/A
N/A	Shared Landing?	N/A			
N/A	Gutter Ponding?	N/A	N/A	Gutter Slope (%)	N/A
N/A	Gutter Lip Ht (in)	N/A	N/A	Gutter X Slope (%)	N/A
N/A	Painted X Walk1?	No	N/A	Painted X Walk2?	N/A
	X Walk 1 Direction	To NW		X Walk 2 Direction	N/A
N/A	X Walk 1 Width (in)	N/A	N/A	X Walk 2 Width (in)	N/A
	X Walk 1 Slope (%)	2.3		X Walk 2 Slope (%)	N/A
	X Walk 1 X Slope (%)	1.7		X Walk 2 X Slope (%)	N/A

N/A	Ramp inside XWalk1?	N/A	N/A	Ramp inside XWalk2?	N/A
	Road Slope (%)	N/A	N/A	Clear Space?	N/A
	Road X Slope (%)	N/A	N/A	Clear Space to XWalk (in)	N/A
N/A	Any Obstructions?	N/A	N/A	Storm Grate/Utility Hazard?	N/A
	Obstruction Type			Storm Grate/Utility Type	
		N/A			N/A
			Yes	Surface Condition? (G/P)	Good

**Remove & Replace Entire Ramp.**
