## Access Compliance Report Public Rights-of-Way (Curb Ramps)

Intersection ID: 23720 Main Street: ELIZABETH\_LN Cross Street: PINEVILLE-MATTHEWS\_RD Location: SE

ADA ID: EBBAD2C9BCB5 Ramp Type: PerpDiag Initial Pass/Fail: Fail Overall Compliance: No Severity Score: 22.5

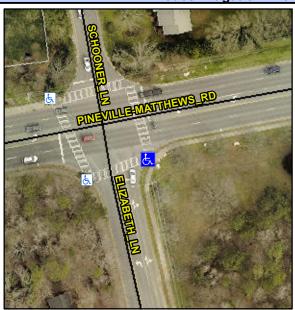
Field Measurements/Component Compliance					
Compliance Description		Data	Comp	liance Description	Data
N/A	Ramp Length (in)	117.0	No	Ramp Slope (%)	8.4
No	Ramp Width (in)	44.0	No	Ramp XSlope (%)	2.6
N/A	Flare Type LT	N/A	N/A	Flare Type RT	N/A
N/A	Flare Slope LT (%)	N/A	N/A	Flare Slope RT (%)	N/A
N/A	Flare Traversable LT?	N/A	N/A	Flare Traversable RT?	N/A
N/A	Landing Length (in)	N/A	N/A	DWS Provided?	N/A
N/A	Landing Width (in)	N/A	N/A	DWS Contrast?	N/A
N/A	Landing Slope (%)	N/A	N/A	DWS Length (in)	N/A
N/A	Landing X Slope (%)	N/A	N/A	DWS Full Width?	N/A
N/A	Landing Curb? (Y/N)	N/A	N/A	DWS Offset (in)	N/A
N/A	Shared Landing?	N/A			
N/A	Gutter Ponding?	N/A	N/A	Gutter Slope (%)	N/A
N/A	Gutter Lip Ht (in)	N/A	N/A	Gutter X Slope (%)	N/A
N/A	Painted X Walk1?	Yes	N/A	Painted X Walk2?	Yes
	X Walk 1 Direction	To N		X Walk 2 Direction	To W
N/A	X Walk 1 Width (in)	109.0	N/A	X Walk 2 Width (in)	99.0
	X Walk 1 Slope (%)	1.3		X Walk 2 Slope (%)	1.5

X Walk 1 X Slope (%)	3.7		X Walk 2 X Slope (%)	3.0
N/A	Ramp inside XWalk1?	Yes	N/A	Ramp inside XWalk2?	Yes
	Road Slope (%)	1.4	N/A	Clear Space?	N/A
	Road X Slope (%)	1.5	N/A	Clear Space to XWalk (in)	N/A
N/A	Any Obstructions?	N/A	N/A	Storm Grate/Utility Hazard?	N/A
	Obstruction Type			Storm Grate/Utility Type	
		N/A			N/A
			Yes	Surface Condition? (G/P)	Good

Remove & Replace Curb Ramp With Two New Directional Ramps or Equivalent.

Not Found, R304.5.1, R304.2.2, R304.5.3
