## **Access Compliance Report Public Rights-of-Way** (Curb Ramps)

Intersection ID: 43119 Main Street: BELLE TERRE AV **Cross Street: THOMAS AV** Ε Location:

Initial Pass/Fail: Fail **Overall Compliance: No Severity Score:** ADA ID: EBC3DB63A3B8 Ramp Type: BlendTrans1 8.75

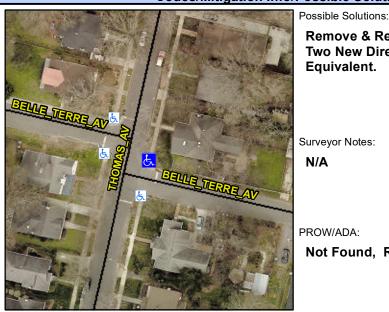
**BELLE TERRE AV** StopSign N/A N/A N/A Flare Type LT N/A N/A Flare Slope LT (%) N/A N/A Flare Traversable LT? N/A N/A Landing Length (in) N/A N/A Landing Width (in) N/A N/A N/A Landing Slope (%) N/A Landing X Slope (%) N/A N/A Landing Curb? (Y/N) N/A N/A N/A Shared Landing? N/A **Gutter Ponding?** Yes N/A Gutter Lip Ht (in) 1.0 N/A Painted X Walk1? No X Walk 1 Direction To S N/A X Walk 1 Width (in) X Walk 1 Slope (%) 4.4 X Walk 1 X Slope (%) 0.2 N/A N/A Ramp inside XWalk1? Road Slope (%) 0.2 Road X Slope (%) 4.4 N/A N/A Any Obstructions?

Street 1 Name Stop Condition-Street 1 Street 2 Name Stop Condition-Street 2 Remove & Replace Curb Ramp With Two New Directional Ramps or Equivalent.

Not Found, R304.5.1
