Access Compliance Report

Public Rights-of-Way

(Curb Ramps)

Intersection ID: 50544	Main Street: ALCEA_ST	Cross Street: CAYENNE_DR	Location: W
ADA ID: EBDAC01E9091	Ramp Type: PerpDiag	Initial Pass/Fail: Fail	Overall Compliance: No
Severity Score: 8.75			
Codes/Mitigation Info/Possible Solution		Field Measurements/Component Compliance

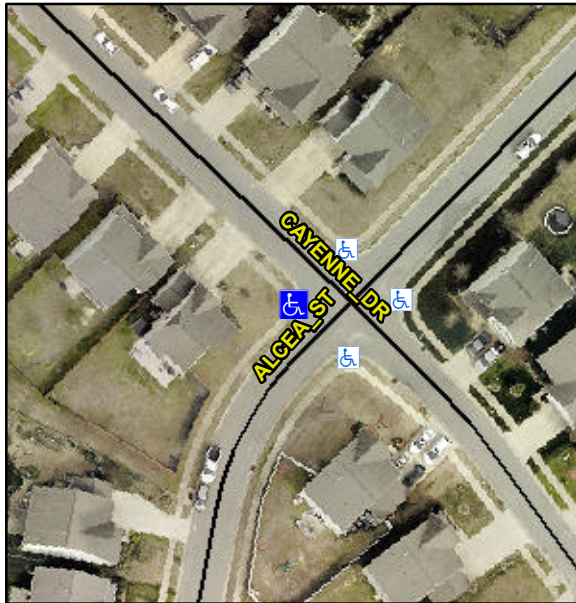
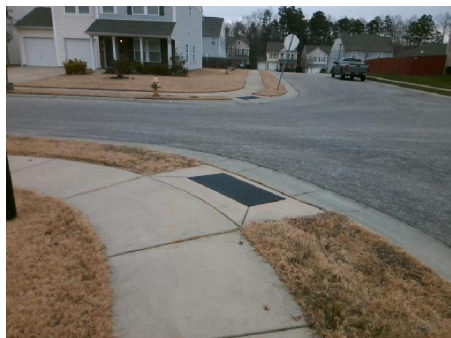
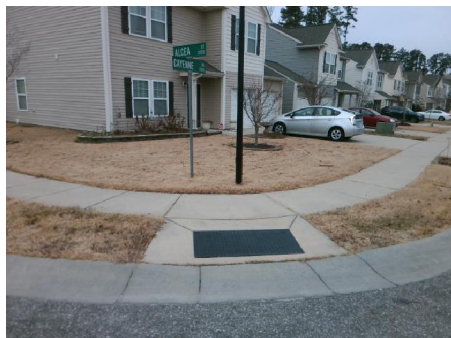
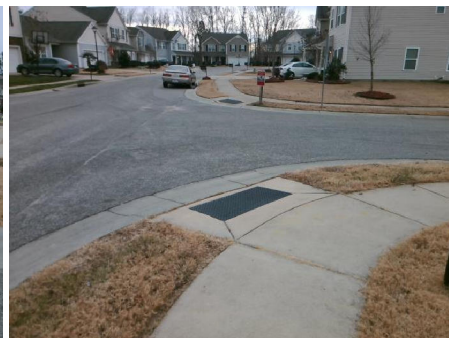
Not Found, R304.5.1

Compliance	Description	Data	Compliance	Description	Data
N/A	Ramp Length (in)	45.0	Yes	Ramp Slope (%)	7.3
No	Ramp Width (in)	45.0	Yes	Ramp XSlope (%)	0.5
N/A	Flare Type LT	N/A	N/A	Flare Type RT	N/A
N/A	Flare Slope LT (%)	N/A	N/A	Flare Slope RT (%)	N/A
N/A	Flare Traversable LT?	N/A	N/A	Flare Traversable RT?	N/A
N/A	Landing Length (in)	N/A	N/A	DWS Provided?	N/A
N/A	Landing Width (in)	N/A	N/A	DWS Contrast?	N/A
N/A	Landing Slope (%)	N/A	N/A	DWS Length (in)	N/A
N/A	Landing X Slope (%)	N/A	N/A	DWS Full Width?	N/A
N/A	Landing Curb? (Y/N)	N/A	N/A	DWS Offset (in)	N/A
N/A	Shared Landing?	N/A			
N/A	Gutter Ponding?	N/A	N/A	Gutter Slope (%)	N/A
N/A	Gutter Lip Ht (in)	N/A	N/A	Gutter X Slope (%)	N/A
N/A	Painted X Walk1?	No	N/A	Painted X Walk2?	No
	X Walk 1 Direction	To SE		X Walk 2 Direction	To NE
N/A	X Walk 1 Width (in)	N/A	N/A	X Walk 2 Width (in)	N/A
	X Walk 1 Slope (%)	0.6		X Walk 2 Slope (%)	0.8
	X Walk 1 X Slope (%)	0.3		X Walk 2 X Slope (%)	2.4

N/A	Ramp inside XWalk1?	N/A	N/A	Ramp inside XWalk2?	N/A
	Road Slope (%)	0.0	N/A	Clear Space?	N/A
	Road X Slope (%)	1.4	N/A	Clear Space to XWalk (in)	N/A
N/A	Any Obstructions?	N/A	N/A	Storm Grate/Utility Hazard?	N/A
	Obstruction Type			Storm Grate/Utility Type	
		N/A			N/A
			Yes	Surface Condition? (G/P)	Good

Remove & Replace Curb Ramp With Two New Directional Ramps or Equivalent.
