# Access Compliance Report

## Public Rights-of-Way

| Intersection ID: 46196 | Main Street: FERNSPRAY_RD | Cross Street: LUSTRE_RD | Location: NE |
| ADA ID: EBDC321B4C57 | Ramp Type: BlendTrans1 | Initial Pass/Fail: Fail | Overall Compliance: No |

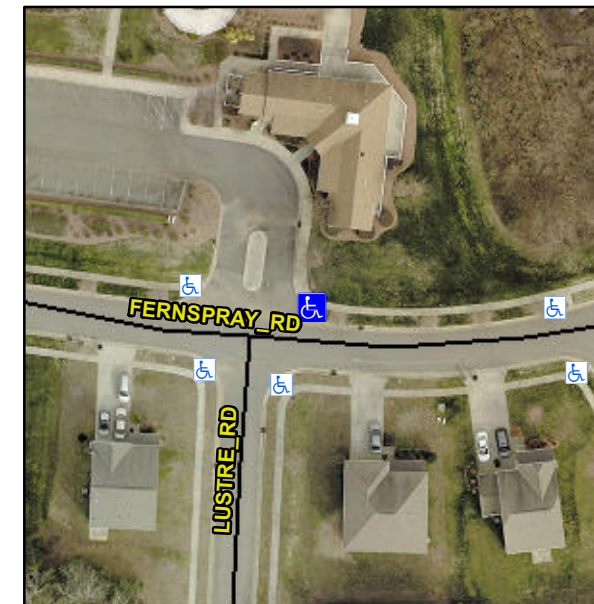
**CURB WIDTH 41.0**

**Not Found, R304.5.3**

| Compliance | Description | Data | Compliance | Description | Data |
|---|---|---|---|---|---|
| Yes | Ramp Width (in) | 48.0 | No | BlendTrans XSlope (%) | 6.2 |
| | | | No | Curb Slope (%) | 7.7 |

**Remove & Replace Curb Ramp With Two New Directional Ramps or Equivalent.**

Total Cost: \$ 3200.00

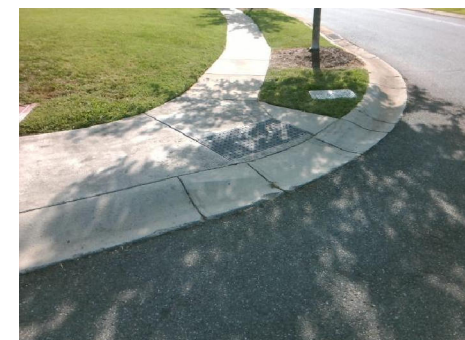
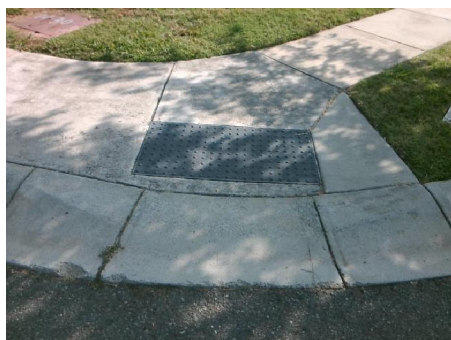
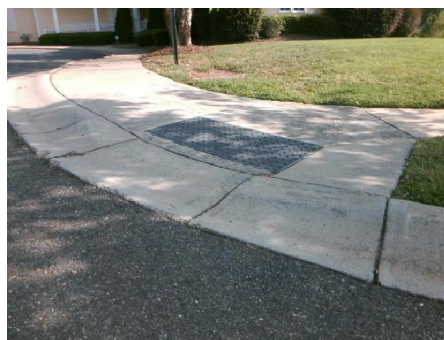
| | | Severity Score: 12.5 | |
