# Access Compliance Report

## Public Rights-of-Way

| Intersection ID: 12082 | Main Street: ALLEN_ST | Cross Street: E_16TH_ST | Location: | N |
| ADA ID: EBE8096BE67D | Ramp Type: Directional1 | Initial Pass/Fail: Pass | Overall Compliance: No | Severity Score: 2.5 |

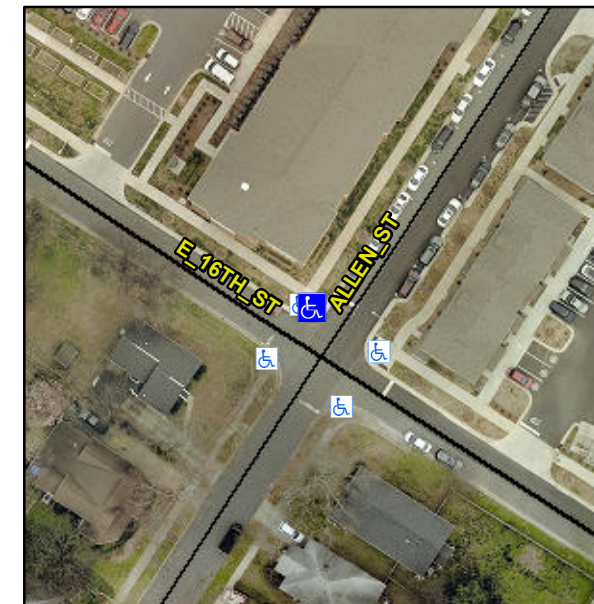
**Not Found, R304.2.2-Perp, R304.3.2-  
Para, R304.5.3, R305.1.4, R305.2**

| Compliance | Description | Data | Compliance | Description | Data |
|---|---|---|---|---|---|
| Yes | Ramp Width (in) | 56.0 | No | Grade Break Slope (%) | 8.9 |
| Yes | Ramp Slope (%) | 6.4 | No | Grade Break XSlope (%) | 3.1 |
| No | Landing Slope (%) | 4.2 | Yes | DWS Length (in) | 24.0 |
| No | Landing X Slope (%) | 2.7 | No | DWS Full Width? | No |
| N/A | Shared Landing? | Yes | No | DWS Offset RT (in) | 2.5 |
| Yes | Gutter Lip Ht (in) | 0.0 | No | Gutter X Slope (%) | 2.9 |

Possible Solutions:

**Remove & Replace Entire Ramp.  
Remove & Replace Gutter.**

Total Cost: \$ 2350.00
