Access Compliance Report

Public Rights-of-Way

(Curb Ramps)

Intersection ID: N/A	Main Street: PAISLEY_ABBEY_LN	Cross Street: KELBURN_LN	Location: NW
ADA ID: EBEB47AC2774	Ramp Type: Perp	Initial Pass/Fail: Fail	Overall Compliance: No
			Severity Score: 21.25

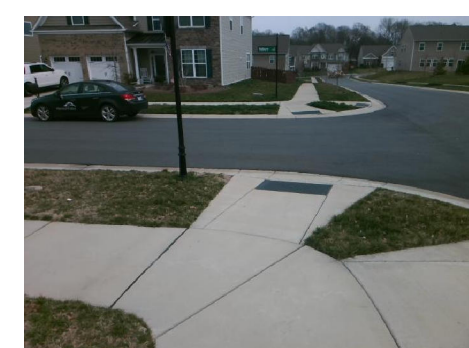
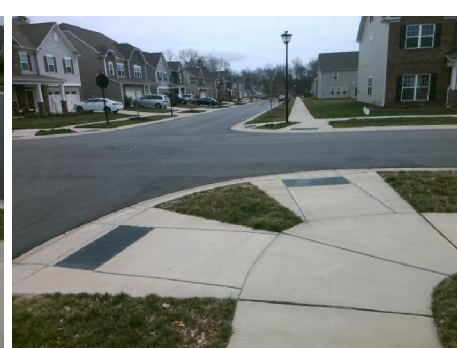
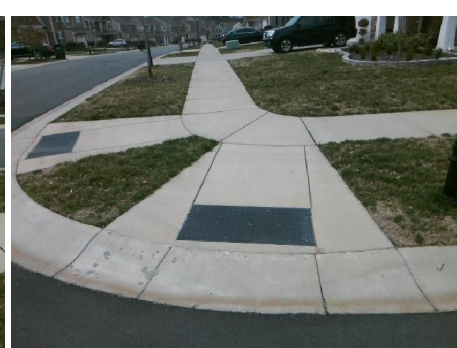
Possible Solutions:		Compliance	Description	Data
	Remove & Replace Entire Ramp.		Yes	Ramp Length (in)	96.0
			No	Ramp Width (in)	47.5
			N/A	Flare Type LT	N/A
			N/A	Flare Slope LT (%)	N/A
			N/A	Flare Traversable LT?	N/A
			N/A	Landing Length (in)	N/A
			N/A	Landing Width (in)	N/A
			N/A	Landing Slope (%)	N/A
			N/A	Landing X Slope (%)	N/A
<p>Surveyor Notes:</p> <p>N/A</p>			N/A	Landing Curb? (Y/N)	N/A
			N/A	Shared Landing?	N/A
			N/A	Gutter Ponding?	N/A
			N/A	Gutter Lip Ht (in)	N/A
			N/A	Painted X Walk1?	No
				X Walk 1 Direction	To NE
			N/A	X Walk 1 Width (in)	N/A
				X Walk 1 Slope (%)	1.2
				X Walk 1 X Slope (%)	2.2
			N/A	Ramp inside XWalk1?	N/A
<p>PROW/ADA:</p> <p>Not Found, R304.5.1, R304.5.3</p>			N/A	Road Slope (%)	N/A
			N/A	Road X Slope (%)	N/A
			N/A	Any Obstructions?	N/A
				Obstruction Type	
			N/A		
			N/A

N/A		
			N/A		
			N/A		
			N/A		
<p>Street 1 Name</p> <p>Stop Condition-Street 2</p> <p>Street 2 Name</p> <p>Stop Condition-Street 1</p>			N/A	Clear Space?	N/A
			N/A	Clear Space to XWalk (in)	N/A
			N/A	Storm Grate/Utility Hazard?	N/A
				Storm Grate/Utility Type	
			N/A		
			N/A		
			N/A		
			N/A		
			N/A		
			N/A		
<p>Total Cost:</p> <p>\$ 1850.00</p>			Yes	Surface Condition? (G/P)	Good
