# Access Compliance Report

## Public Rights-of-Way

### (Curb Ramps)

Intersection ID: 5859	Main Street: CONIFER_CR	Cross Street: ST_JOSEPH_DR	Location: S
ADA ID: EBF42356BFDB	Ramp Type: Perp	Initial Pass/Fail: Fail	Overall Compliance: No
		Severity Score: 8.75	
Codes/Mitigation Info/Possible Solution		Field Measurements/Component Compliance

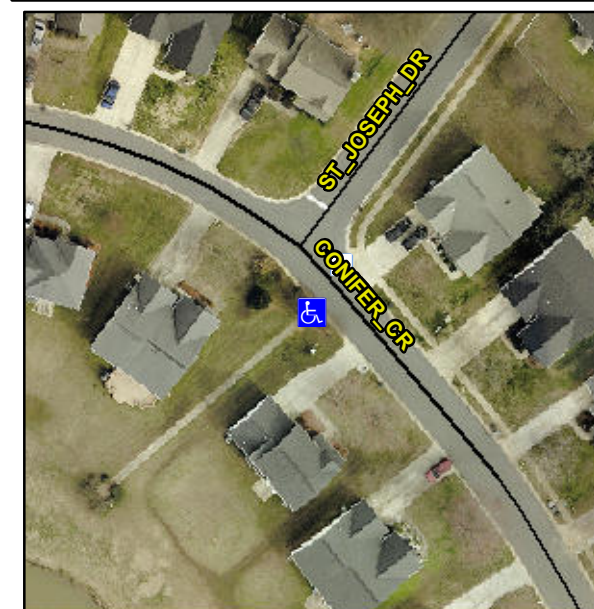
**Not Found, R304.5.1**

Compliance	Description	Data	Compliance	Description	Data
N/A	Ramp Length (in)	40.5	Yes	Ramp Slope (%)	5.3
No	Ramp Width (in)	47.0	Yes	Ramp XSlope (%)	0.1
N/A	Flare Type LT	N/A	N/A	Flare Type RT	N/A
N/A	Flare Slope LT (%)	N/A	N/A	Flare Slope RT (%)	N/A
N/A	Flare Traversable LT?	N/A	N/A	Flare Traversable RT?	N/A
N/A	Landing Length (in)	N/A	N/A	DWS Provided?	N/A
N/A	Landing Width (in)	N/A	N/A	DWS Contrast?	N/A
N/A	Landing Slope (%)	N/A	N/A	DWS Length (in)	N/A
N/A	Landing X Slope (%)	N/A	N/A	DWS Full Width?	N/A
N/A	Landing Curb? (Y/N)	N/A	N/A	DWS Offset (in)	N/A
N/A	Shared Landing?	N/A			
N/A	Gutter Ponding?	N/A	N/A	Gutter Slope (%)	N/A
N/A	Gutter Lip Ht (in)	N/A	N/A	Gutter X Slope (%)	N/A
N/A	Painted X Walk1?	No	N/A	Painted X Walk2?	N/A
	X Walk 1 Direction	To E		X Walk 2 Direction	N/A
N/A	X Walk 1 Width (in)	N/A	N/A	X Walk 2 Width (in)	N/A
	X Walk 1 Slope (%)	3.6		X Walk 2 Slope (%)	N/A
	X Walk 1 X Slope (%)	0.6		X Walk 2 X Slope (%)	N/A

N/A	Ramp inside XWalk1?	N/A	N/A	Ramp inside XWalk2?	N/A
	Road Slope (%)	N/A	N/A	Clear Space?	N/A
	Road X Slope (%)	N/A	N/A	Clear Space to XWalk (in)	N/A
N/A	Any Obstructions?	N/A	N/A	Storm Grate/Utility Hazard?	N/A
	Obstruction Type			Storm Grate/Utility Type	
		N/A			N/A
			Yes	Surface Condition? (G/P)	Good

**Remove & Replace Entire Ramp.**
