# Access Compliance Report

## Public Rights-of-Way

### (Curb Ramps)

Intersection ID: 20109	Main Street: COLUMBINE_CR	Cross Street: COLUMBINE_CT	Location: SE
ADA ID: EBFFB926C7F0	Ramp Type: PerpDiag	Initial Pass/Fail: Fail	Overall Compliance: No
Severity Score: 8.75			
Codes/Mitigation Info/Possible Solution		Field Measurements/Component Compliance

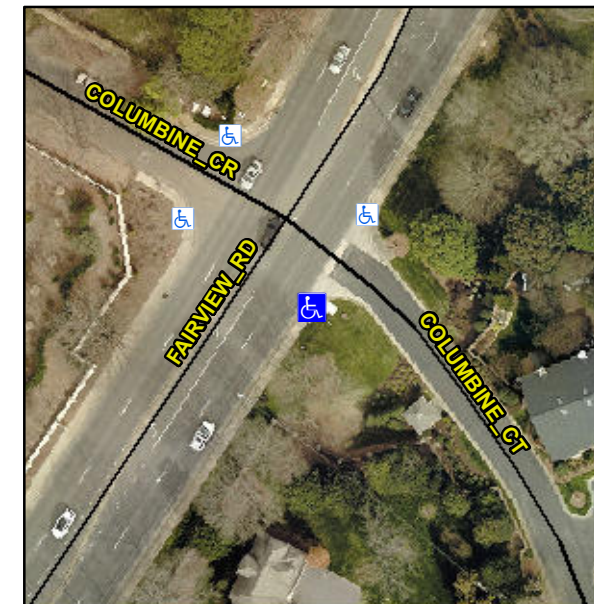
**Not Found, R304.5.1**

Compliance	Description	Data	Compliance	Description	Data
N/A	Ramp Length (in)	60.0	Yes	Ramp Slope (%)	5.8
No	Ramp Width (in)	44.0	Yes	Ramp XSlope (%)	1.8
N/A	Flare Type LT	N/A	N/A	Flare Type RT	N/A
N/A	Flare Slope LT (%)	N/A	N/A	Flare Slope RT (%)	N/A
N/A	Flare Traversable LT?	N/A	N/A	Flare Traversable RT?	N/A
N/A	Landing Length (in)	N/A	N/A	DWS Provided?	N/A
N/A	Landing Width (in)	N/A	N/A	DWS Contrast?	N/A
N/A	Landing Slope (%)	N/A	N/A	DWS Length (in)	N/A
N/A	Landing X Slope (%)	N/A	N/A	DWS Full Width?	N/A
N/A	Landing Curb? (Y/N)	N/A	N/A	DWS Offset (in)	N/A
N/A	Shared Landing?	N/A			
N/A	Gutter Ponding?	N/A	N/A	Gutter Slope (%)	N/A
N/A	Gutter Lip Ht (in)	N/A	N/A	Gutter X Slope (%)	N/A
N/A	Painted X Walk1?	No	N/A	Painted X Walk2?	No
	X Walk 1 Direction	To NE		X Walk 2 Direction	To NW
N/A	X Walk 1 Width (in)	N/A	N/A	X Walk 2 Width (in)	N/A
	X Walk 1 Slope (%)	1.3		X Walk 2 Slope (%)	0.6
	X Walk 1 X Slope (%)	1.3		X Walk 2 X Slope (%)	0.8

N/A	Ramp inside XWalk1?	N/A	N/A	Ramp inside XWalk2?	N/A
	Road Slope (%)	1.4	N/A	Clear Space?	N/A
	Road X Slope (%)	0.5	N/A	Clear Space to XWalk (in)	N/A
N/A	Any Obstructions?	N/A	N/A	Storm Grate/Utility Hazard?	N/A
	Obstruction Type			Storm Grate/Utility Type	
		N/A			N/A
		Yes		Surface Condition? (G/P)	Good

**Remove & Replace Curb Ramp With Two New Directional Ramps or Equivalent.**

Total Cost: \$ 3200.00
