Access Compliance Report

Public Rights-of-Way

(Curb Ramps)

Intersection ID: 12611	Main Street: S_CHURCH_ST	Cross Street: W_STONEWALL_ST	Location: E
ADA ID: EC08091DB7E4	Ramp Type: Perp	Initial Pass/Fail: Pass	Overall Compliance: No
Severity Score: 0			
Codes/Mitigation Info/Possible Solution		Field Measurements/Component Compliance

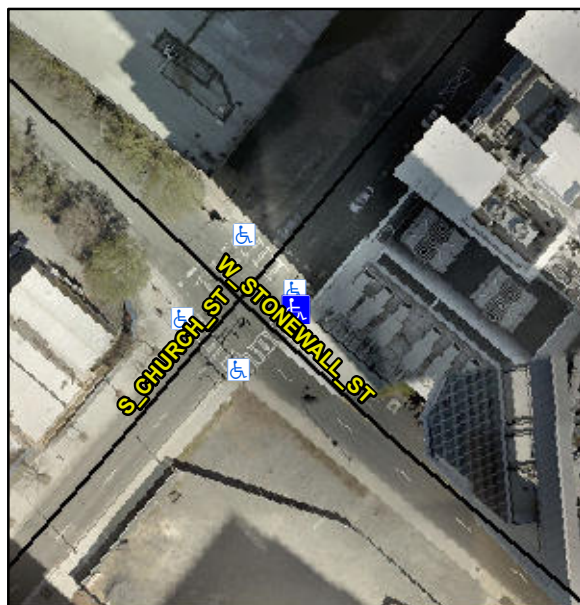
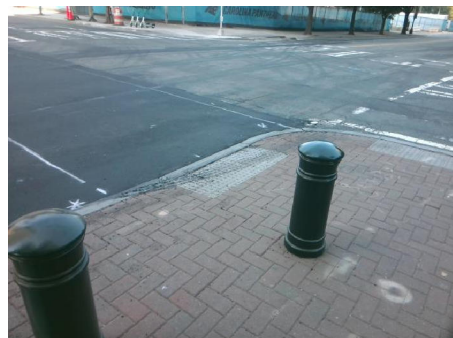
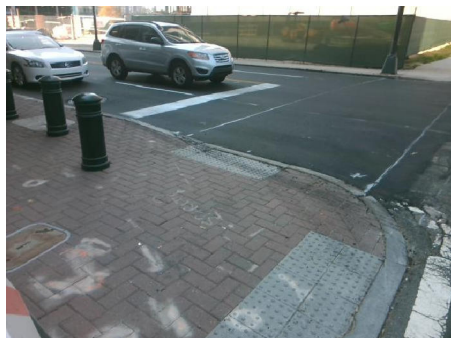
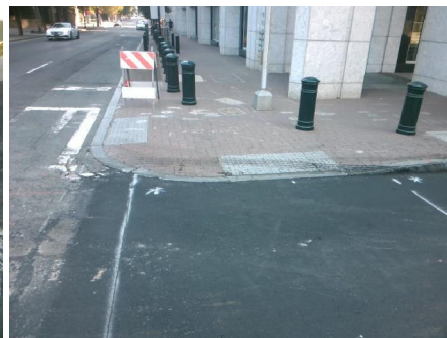
Not Found, R304.2.1, R304.2.2-Perp, R304.3.2-Para

Compliance	Description	Data	Compliance	Description	Data
N/A	Ramp Length (in)	32.0	Yes	Ramp Slope (%)	6.0
Yes	Ramp Width (in)	59.0	Yes	Ramp XSlope (%)	1.6
N/A	Flare Type LT	Sloped	N/A	Flare Type RT	N/A
N/A	Flare Slope LT (%)	3.6	Yes	Flare Slope RT (%)	5.8
N/A	Flare Traversable LT?	Yes	N/A	Flare Traversable RT?	Yes
No	Landing Length (in)	44.0	Yes	DWS Provided?	Yes
Yes	Landing Width (in)	60.0	Yes	DWS Contrast?	Yes
No	Landing Slope (%)	3.2	Yes	DWS Length (in)	24.0
Yes	Landing X Slope (%)	0.0	Yes	DWS Full Width?	Yes
N/A	Landing Curb? (Y/N)	No	Yes	DWS Offset (in)	0.0
N/A	Shared Landing?	Yes			
Yes	Gutter Ponding?	No	Yes	Gutter Slope (%)	0.8
Yes	Gutter Lip Ht (in)	0.0	Yes	Gutter X Slope (%)	1.3
N/A	Painted X Walk1?	No	N/A	Painted X Walk2?	N/A
	X Walk 1 Direction	To SW		X Walk 2 Direction	N/A
N/A	X Walk 1 Width (in)	N/A	N/A	X Walk 2 Width (in)	N/A
	X Walk 1 Slope (%)	1.2		X Walk 2 Slope (%)	N/A
	X Walk 1 X Slope (%)	1.5		X Walk 2 X Slope (%)	N/A

N/A	Ramp inside XWalk1?	N/A	N/A	Ramp inside XWalk2?	N/A
	Road Slope (%)	N/A	N/A	Clear Space?	Yes
	Road X Slope (%)	N/A	N/A	Clear Space to XWalk (in)	N/A
Yes	Any Obstructions?	No	Yes	Storm Grate/Utility Hazard?	No
	Obstruction Type			Storm Grate/Utility Type	
		N/A			N/A
			Yes	Surface Condition? (G/P)	Good

Remove & Replace Entire Ramp.
