Access Compliance Report

Public Rights-of-Way

(Curb Ramps)

Intersection ID: 15589	Main Street: MIDDLETON_DR	Cross Street: PROVIDENCE_RD	Location: NE
ADA ID: EC096AD1F8D4	Ramp Type: PerpDiag	Initial Pass/Fail: Fail	Overall Compliance: No
Codes/Mitigation Info/Possible Solution		Field Measurements/Component Compliance	
Severity Score: 8.75

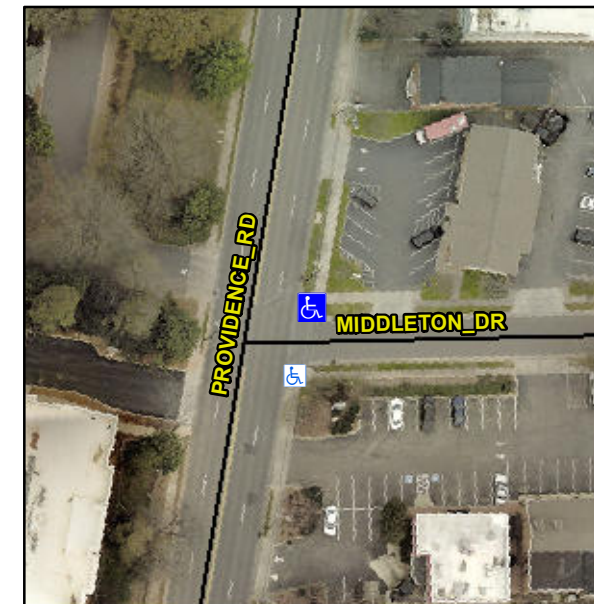
Not Found, R304.5.1

Compliance	Description	Data	Compliance	Description	Data
N/A	Ramp Length (in)	65.0	Yes	Ramp Slope (%)	8.1
No	Ramp Width (in)	47.0	Yes	Ramp XSlope (%)	0.2
N/A	Flare Type LT	N/A	N/A	Flare Type RT	N/A
N/A	Flare Slope LT (%)	N/A	N/A	Flare Slope RT (%)	N/A
N/A	Flare Traversable LT?	N/A	N/A	Flare Traversable RT?	N/A
N/A	Landing Length (in)	N/A	N/A	DWS Provided?	N/A
N/A	Landing Width (in)	N/A	N/A	DWS Contrast?	N/A
N/A	Landing Slope (%)	N/A	N/A	DWS Length (in)	N/A
N/A	Landing X Slope (%)	N/A	N/A	DWS Full Width?	N/A
N/A	Landing Curb? (Y/N)	N/A	N/A	DWS Offset (in)	N/A
N/A	Shared Landing?	N/A			
N/A	Gutter Ponding?	N/A	N/A	Gutter Slope (%)	N/A
N/A	Gutter Lip Ht (in)	N/A	N/A	Gutter X Slope (%)	N/A
N/A	Painted X Walk1?	No	N/A	Painted X Walk2?	No
	X Walk 1 Direction	To W		X Walk 2 Direction	To S
N/A	X Walk 1 Width (in)	N/A	N/A	X Walk 2 Width (in)	N/A
	X Walk 1 Slope (%)	3.7		X Walk 2 Slope (%)	1.0
	X Walk 1 X Slope (%)	4.6		X Walk 2 X Slope (%)	1.0

N/A	Ramp inside XWalk1?	N/A	N/A	Ramp inside XWalk2?	N/A
	Road Slope (%)	1.5	N/A	Clear Space?	N/A
	Road X Slope (%)	4.3	N/A	Clear Space to XWalk (in)	N/A
N/A	Any Obstructions?	N/A	N/A	Storm Grate/Utility Hazard?	N/A
	Obstruction Type			Storm Grate/Utility Type	
		N/A			N/A
		Yes		Surface Condition? (G/P)	Good

Remove & Replace Curb Ramp With Two New Directional Ramps or Equivalent.
