Intersection ID: 10936	Main Street: LITTLE_ROCK_RD	Cross Street: SCOTT_FUTRELL_DR	Location:	SW
ADA ID: EC1067FCC674	Ramp Type: Para	Initial Pass/Fail: Fail	Overall Compliance: No	Severity Score: 12.5

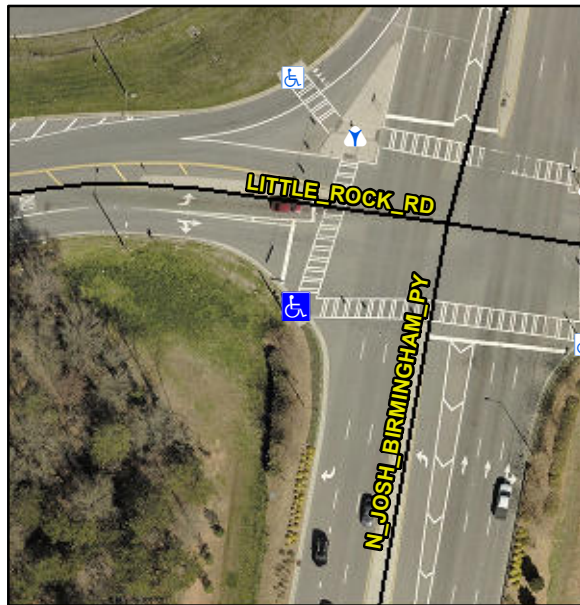
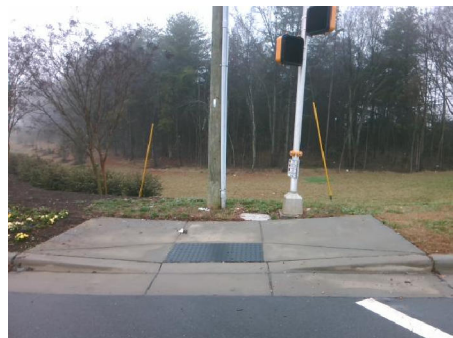
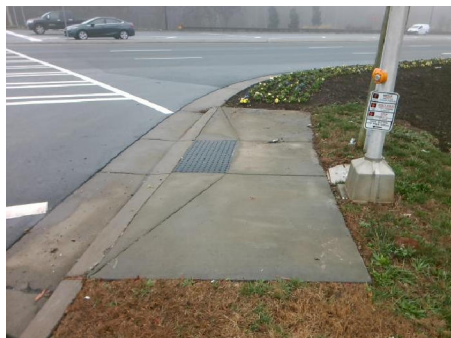
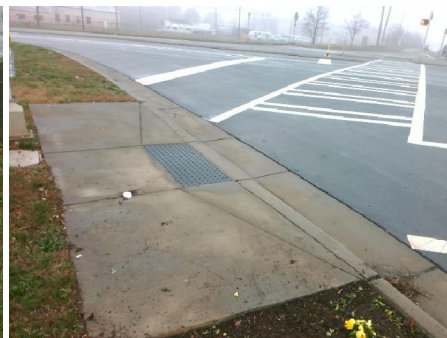
LT RP < 5%

R304.3.2

Compliance	Description	Data	Compliance	Description	Data
N/A	Ramp Length LT (in)	62.5	N/A	Ramp Length RT (in)	70.5
Yes	Ramp Width LT (in)	67.0	Yes	Ramp Width RT (in)	67.0
Yes	Ramp Slope LT (%)	0.1	No	Ramp Slope RT (%)	10.1
Yes	Ramp XSlope LT (%)	1.9	Yes	Ramp XSlope RT (%)	1.3
N/A	Landing Length (in)	N/A	N/A	DWS Provided?	N/A
N/A	Landing Width (in)	N/A	N/A	DWS Contrast?	N/A
N/A	Landing Slope (%)	N/A	N/A	DWS Length (in)	N/A
N/A	Landing X Slope (%)	N/A	N/A	DWS Full Width?	N/A
N/A	Landing Curb? (Y/N)	N/A	N/A	DWS Offset (in)	N/A
N/A	Shared Landing?	N/A			
N/A	Gutter Ponding?	N/A	N/A	Gutter Slope (%)	N/A
N/A	Gutter Lip Ht (in)	N/A	N/A	Gutter X Slope (%)	N/A
N/A	Painted X Walk1?	Yes	N/A	Painted X Walk2?	Yes
	X Walk 1 Direction	To E		X Walk 2 Direction	To N
N/A	X Walk 1 Width (in)	113.0	N/A	X Walk 2 Width (in)	113.0
	X Walk 1 Slope (%)	0.5		X Walk 2 Slope (%)	5.5
	X Walk 1 X Slope (%)	5.5		X Walk 2 X Slope (%)	1.6

N/A	Ramp inside XWalk1?	Yes	N/A	Ramp inside XWalk2?	Yes
	Road Slope (%)	5.3	N/A	Clear Space?	N/A
	Road X Slope (%)	3.2	N/A	Clear Space to XWalk (in)	N/A
N/A	Any Obstructions?	N/A	N/A	Storm Grate/Utility Hazard?	N/A
	Obstruction Type			Storm Grate/Utility Type	
		N/A			N/A
			Yes	Surface Condition? (G/P)	Good
			N/A	Curb Slope (%)	9.6

Remove & Replace Entire Ramp.
