Access Compliance Report

Public Rights-of-Way

(Curb Ramps)

Intersection ID: 50592	Main Street: BENDING_BRANCH_RD	Cross Street: BRISTLEY_RD	Location: SE
ADA ID: EC1410C16FD6	Ramp Type: Perp	Initial Pass/Fail: Pass	Overall Compliance: No
Severity Score: 5			
Codes/Mitigation Info/Possible Solution		Field Measurements/Component Compliance

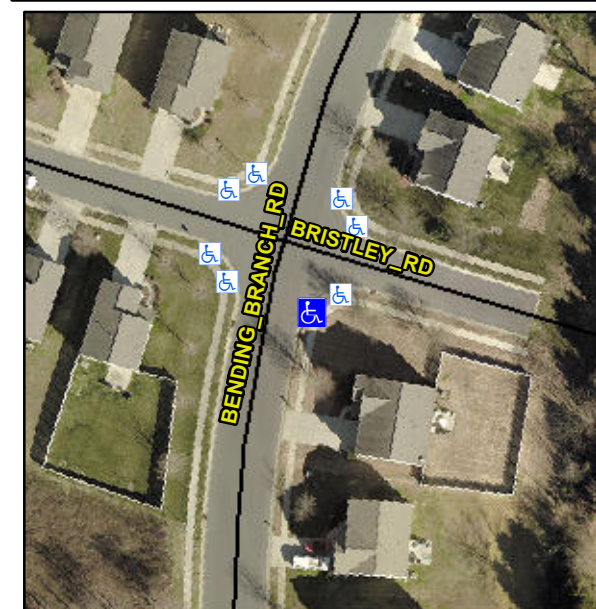
**Not Found, R304.2.2-Perp, R304.3.2-
Para, R304.5.3, R305.2, R304.5.4**

Compliance	Description	Data	Compliance	Description	Data
N/A	Ramp Length (in)	48.0	Yes	Ramp Slope (%)	7.0
Yes	Ramp Width (in)	48.0	Yes	Ramp XSlope (%)	1.9
N/A	Flare Type LT	Sloped	N/A	Flare Type RT	N/A
N/A	Flare Slope LT (%)	4.3	N/A	Flare Slope RT (%)	5.3
N/A	Flare Traversable LT?	No	N/A	Flare Traversable RT?	No
Yes	Landing Length (in)	48.0	Yes	DWS Provided?	Yes
Yes	Landing Width (in)	90.0	Yes	DWS Contrast?	Yes
No	Landing Slope (%)	2.1	Yes	DWS Length (in)	24.5
No	Landing X Slope (%)	2.2	Yes	DWS Full Width?	Yes
N/A	Landing Curb? (Y/N)	No	No	DWS Offset (in)	6.5
N/A	Shared Landing?	Yes			
Yes	Gutter Ponding?	No	No	Gutter Slope (%)	14.1
Yes	Gutter Lip Ht (in)	0.0	Yes	Gutter X Slope (%)	0.8
N/A	Painted X Walk1?	No	N/A	Painted X Walk2?	N/A
	X Walk 1 Direction	To NW		X Walk 2 Direction	N/A
N/A	X Walk 1 Width (in)	N/A	N/A	X Walk 2 Width (in)	N/A
	X Walk 1 Slope (%)	0.3		X Walk 2 Slope (%)	N/A
	X Walk 1 X Slope (%)	2.4		X Walk 2 X Slope (%)	N/A

N/A	Ramp inside XWalk1?	N/A	N/A	Ramp inside XWalk2?	N/A
	Road Slope (%)	N/A	N/A	Clear Space?	Yes
	Road X Slope (%)	N/A	N/A	Clear Space to XWalk (in)	N/A
Yes	Any Obstructions?	No	Yes	Storm Grate/Utility Hazard?	No
	Obstruction Type			Storm Grate/Utility Type	
		N/A			N/A
			Yes	Surface Condition? (G/P)	Good

**Remove & Replace Entire Ramp.
Remove & Replace Gutter.**
