# Access Compliance Report

## Public Rights-of-Way

### (Curb Ramps)

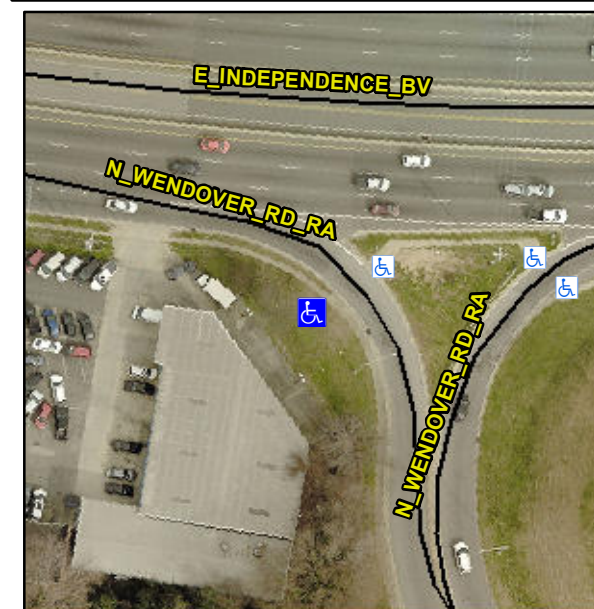
Intersection ID: 15242	Main Street: E_INDEPENDENCE_BV	Cross Street: N_WENDOVER_RD_RA	Location: SW
ADA ID: EC17416CCE49	Ramp Type: Perp	Initial Pass/Fail: Fail	Overall Compliance: No
Severity Score: 35			
Codes/Mitigation Info/Possible Solution		Field Measurements/Component Compliance

**Not Found, R304.5.1, R304.2.2, R304.5.3**

Compliance	Description	Data	Compliance	Description	Data
N/A	Ramp Length (in)	61.0	No	Ramp Slope (%)	13.3
No	Ramp Width (in)	38.5	No	Ramp XSlope (%)	2.6
N/A	Flare Type LT	N/A	N/A	Flare Type RT	N/A
N/A	Flare Slope LT (%)	N/A	N/A	Flare Slope RT (%)	N/A
N/A	Flare Traversable LT?	N/A	N/A	Flare Traversable RT?	N/A
N/A	Landing Length (in)	N/A	N/A	DWS Provided?	N/A
N/A	Landing Width (in)	N/A	N/A	DWS Contrast?	N/A
N/A	Landing Slope (%)	N/A	N/A	DWS Length (in)	N/A
N/A	Landing X Slope (%)	N/A	N/A	DWS Full Width?	N/A
N/A	Landing Curb? (Y/N)	N/A	N/A	DWS Offset (in)	N/A
N/A	Shared Landing?	N/A			
N/A	Gutter Ponding?	N/A	N/A	Gutter Slope (%)	N/A
N/A	Gutter Lip Ht (in)	N/A	N/A	Gutter X Slope (%)	N/A
N/A	Painted X Walk1?	No	N/A	Painted X Walk2?	N/A
	X Walk 1 Direction	To NE		X Walk 2 Direction	N/A
N/A	X Walk 1 Width (in)	N/A	N/A	X Walk 2 Width (in)	N/A
	X Walk 1 Slope (%)	4.8		X Walk 2 Slope (%)	N/A
	X Walk 1 X Slope (%)	2.0		X Walk 2 X Slope (%)	N/A

**Remove & Replace Entire Ramp.**
