Access Compliance Report

Public Rights-of-Way

(Curb Ramps)

Intersection ID: 12565	Main Street: E_10TH_ST	Cross Street: E_11TH_ST	Location: NW
ADA ID: EC1C0986F607	Ramp Type: Perp	Initial Pass/Fail: Fail	Overall Compliance: No
Severity Score: 12.5			
Codes/Mitigation Info/Possible Solution		Field Measurements/Component Compliance

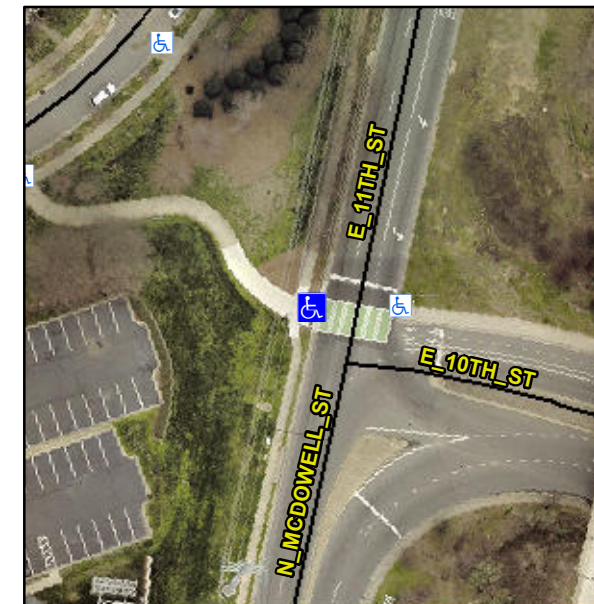
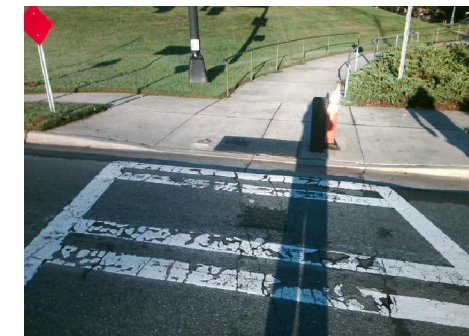
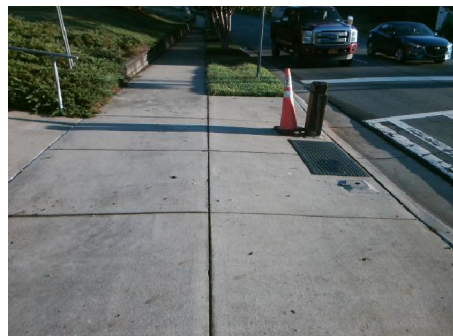
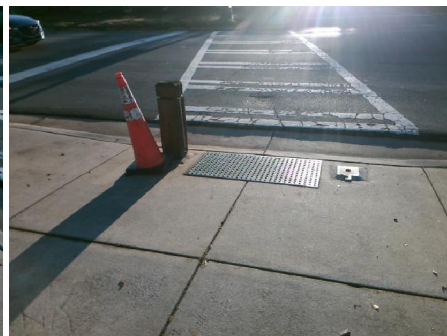
Not Found, R304.2.2

Compliance	Description	Data	Compliance	Description	Data
N/A	Ramp Length (in)	72.5	No	Ramp Slope (%)	8.5
Yes	Ramp Width (in)	48.0	Yes	Ramp XSlope (%)	1.8
N/A	Flare Type LT	N/A	N/A	Flare Type RT	N/A
N/A	Flare Slope LT (%)	N/A	N/A	Flare Slope RT (%)	N/A
N/A	Flare Traversable LT?	N/A	N/A	Flare Traversable RT?	N/A
N/A	Landing Length (in)	N/A	N/A	DWS Provided?	N/A
N/A	Landing Width (in)	N/A	N/A	DWS Contrast?	N/A
N/A	Landing Slope (%)	N/A	N/A	DWS Length (in)	N/A
N/A	Landing X Slope (%)	N/A	N/A	DWS Full Width?	N/A
N/A	Landing Curb? (Y/N)	N/A	N/A	DWS Offset (in)	N/A
N/A	Shared Landing?	N/A			
N/A	Gutter Ponding?	N/A	N/A	Gutter Slope (%)	N/A
N/A	Gutter Lip Ht (in)	2.0	N/A	Gutter X Slope (%)	N/A
N/A	Painted X Walk1?	Yes	N/A	Painted X Walk2?	N/A
	X Walk 1 Direction	To E		X Walk 2 Direction	N/A
N/A	X Walk 1 Width (in)	110.0	N/A	X Walk 2 Width (in)	N/A
	X Walk 1 Slope (%)	0.2		X Walk 2 Slope (%)	N/A
	X Walk 1 X Slope (%)	2.1		X Walk 2 X Slope (%)	N/A

N/A	Ramp inside XWalk1?	Yes	N/A	Ramp inside XWalk2?	N/A
	Road Slope (%)	N/A	N/A	Clear Space?	N/A
	Road X Slope (%)	N/A	N/A	Clear Space to XWalk (in)	N/A
N/A	Any Obstructions?	N/A	N/A	Storm Grate/Utility Hazard?	N/A
	Obstruction Type			Storm Grate/Utility Type	
		N/A			N/A
		Yes		Surface Condition? (G/P)	Good

Remove & Replace Entire Ramp.
