# Access Compliance Report

## Public Rights-of-Way

### (Curb Ramps)

Intersection ID: 2897	Main Street: BELL'S_MILL_DR	Cross Street: HARBURN_FOREST_DR	Location: SE
ADA ID: EC1D5BE06A0F	Ramp Type: PerpDiag	Initial Pass/Fail: Pass	Overall Compliance: No
Severity Score: 22.75			
Codes/Mitigation Info/Possible Solution		Field Measurements/Component Compliance

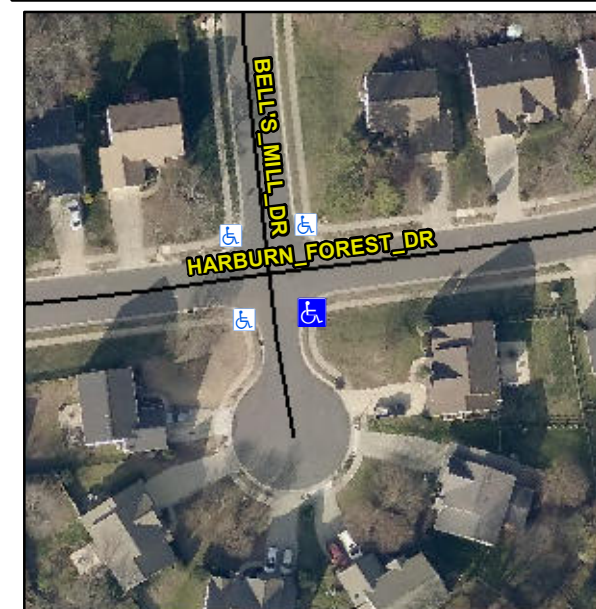
Compliance	Description	Data	Compliance	Description	Data
N/A	Ramp Length (in)	36.0	Yes	Ramp Slope (%)	6.7
Yes	Ramp Width (in)	72.0	No	Ramp XSlope (%)	4.2
N/A	Flare Type LT	Sloped	N/A	Flare Type RT	N/A
N/A	Flare Slope LT (%)	3.6	Yes	Flare Slope RT (%)	6.9
N/A	Flare Traversable LT?	Yes	N/A	Flare Traversable RT?	Yes
Yes	Landing Length (in)	48.0	No	DWS Provided?	No
Yes	Landing Width (in)	72.0	N/A	DWS Contrast?	No
No	Landing Slope (%)	2.8	N/A	DWS Length (in)	N/A
No	Landing X Slope (%)	4.1	N/A	DWS Full Width?	No
N/A	Landing Curb? (Y/N)	No	N/A	DWS Offset (in)	N/A
N/A	Shared Landing?	No			
Yes	Gutter Ponding?	No	No	Gutter Slope (%)	7.8
No	Gutter Lip Ht (in)	0.5	No	Gutter X Slope (%)	3.5
N/A	Painted X Walk1?	No	N/A	Painted X Walk2?	No
	X Walk 1 Direction	To N		X Walk 2 Direction	To W
N/A	X Walk 1 Width (in)	N/A	N/A	X Walk 2 Width (in)	N/A
	X Walk 1 Slope (%)	0.7		X Walk 2 Slope (%)	3.3
	X Walk 1 X Slope (%)	3.4		X Walk 2 X Slope (%)	0.1

N/A	Ramp inside XWalk1?	N/A	N/A	Ramp inside XWalk2?	N/A
	Road Slope (%)	0.5	N/A	Clear Space?	Yes
	Road X Slope (%)	2.4	N/A	Clear Space to XWalk (in)	N/A
Yes	Any Obstructions?	No	Yes	Storm Grate/Utility Hazard?	No
	Obstruction Type			Storm Grate/Utility Type	
		N/A			N/A
		Yes		Surface Condition? (G/P)	Good

**Remove & Replace Curb Ramp With Two New Directional Ramps or Equivalent. Remove & Replace Gutter.**
