Access Compliance Report

Public Rights-of-Way

(Curb Ramps)

Intersection ID: 10031808	Main Street: MILLENNIUM_AV	Cross Street: POTOMAC_RIVER_PY	Location: N
ADA ID: EC22C251A7D8	Ramp Type: Directional1	Initial Pass/Fail: Fail	Overall Compliance: No
		Severity Score: 1.25

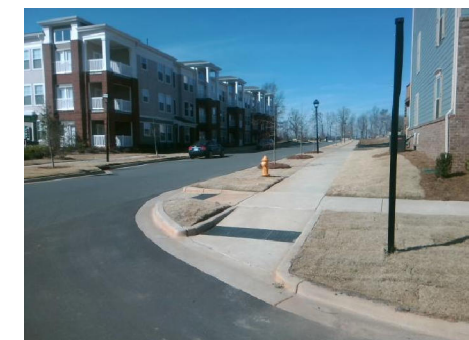
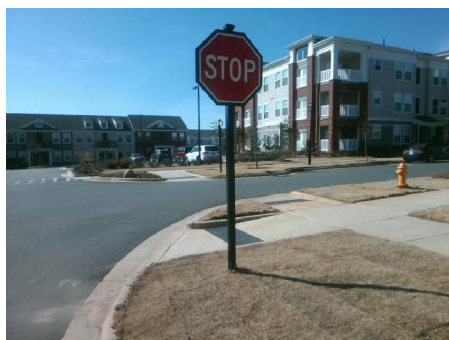
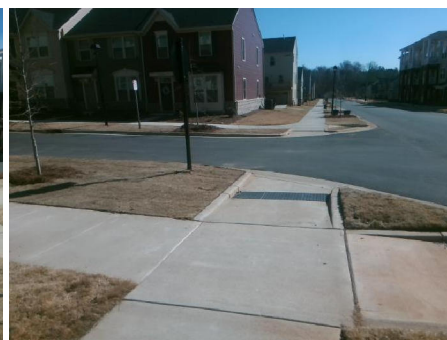
R304.5.3

Compliance	Description	Data	Compliance	Description	Data
N/A	Ramp Length (in)	85.0	N/A	Grade Break?	N/A
Yes	Ramp Width (in)	72.0	N/A	Grade Break Slope (%)	0.0
Yes	Ramp Slope (%)	8.0	N/A	Grade Break XSlope (%)	0.0
No	Ramp XSlope (%)	2.5			
N/A	Flare Type LT	N/A	N/A	Flare Type RT	N/A
N/A	Flare Slope LT (%)	N/A	N/A	Flare Slope RT (%)	0.0
N/A	Flare Traversable LT?	N/A	N/A	Flare Traversable RT?	N/A
N/A	Landing Length (in)	0.0	N/A	DWS Provided?	N/A
N/A	Landing Width (in)	0.0	N/A	DWS Contrast?	N/A
N/A	Landing Slope (%)	0.0	N/A	DWS Length (in)	N/A
N/A	Landing X Slope (%)	0.0	N/A	DWS Full Width?	N/A
N/A	Landing Curb? (Y/N)	N/A	N/A	DWS Offset LT (in)	N/A
N/A	Shared Landing?	N/A	N/A	DWS Offset RT (in)	N/A
N/A	Gutter Ponding?	0.0	N/A	Gutter Slope (%)	N/A
N/A	Gutter Lip Ht (in)	0.0	N/A	Gutter X Slope (%)	N/A
N/A	Painted X Walk1?	No		Road Slope (%)	1.3
	X Walk 1 Direction	To SE		Road X Slope (%)	0.8
	X Walk 1 Width (in)	N/A		Clear Space?	N/A

X Walk 1 Slope (%)	1.3	N/A	Clear Space to XWalk (in)	N/A
	X Walk 1 X Slope (%)	0.8	N/A	Storm Grate/Utility Hazard?	N/A
N/A	Ramp inside XWalk1?	N/A		Storm Grate/Utility Type	
N/A	Any Obstructions?	N/A			N/A
	Obstruction Type		Yes	Surface Condition? (G/P)	Good
			N/A	Curb Slope (%)	1.5

Possible Solutions:

Remove & Replace Entire Ramp.
