Access Compliance Report

Public Rights-of-Way

(Curb Ramps)

Intersection ID: 44872	Main Street: HUFFINES_LN	Cross Street: BALLANTYNE_COMMONS_PY	Location: NE
ADA ID: EC269B6E4BFA	Ramp Type: Perp	Initial Pass/Fail: Fail	Overall Compliance: No
Codes/Mitigation Info/Possible Solution			Severity Score: 10
Field Measurements/Component Compliance

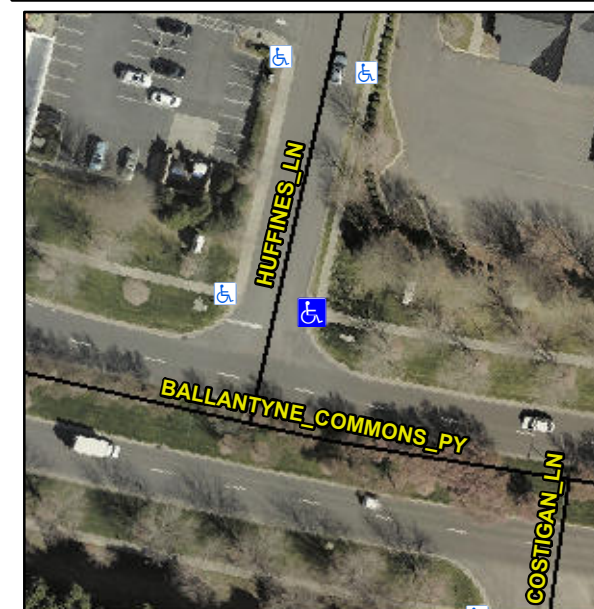
Not Found, R304.5.1, R304.5.3

Compliance	Description	Data	Compliance	Description	Data
N/A	Ramp Length (in)	134.0	Yes	Ramp Slope (%)	6.9
No	Ramp Width (in)	37.5	No	Ramp XSlope (%)	4.0
N/A	Flare Type LT	N/A	N/A	Flare Type RT	N/A
N/A	Flare Slope LT (%)	N/A	N/A	Flare Slope RT (%)	N/A
N/A	Flare Traversable LT?	N/A	N/A	Flare Traversable RT?	N/A
N/A	Landing Length (in)	N/A	N/A	DWS Provided?	N/A
N/A	Landing Width (in)	N/A	N/A	DWS Contrast?	N/A
N/A	Landing Slope (%)	N/A	N/A	DWS Length (in)	N/A
N/A	Landing X Slope (%)	N/A	N/A	DWS Full Width?	N/A
N/A	Landing Curb? (Y/N)	N/A	N/A	DWS Offset (in)	N/A
N/A	Shared Landing?	N/A			
N/A	Gutter Ponding?	N/A	N/A	Gutter Slope (%)	N/A
N/A	Gutter Lip Ht (in)	N/A	N/A	Gutter X Slope (%)	N/A
N/A	Painted X Walk1?	No	N/A	Painted X Walk2?	N/A
	X Walk 1 Direction	To NW		X Walk 2 Direction	N/A
N/A	X Walk 1 Width (in)	N/A	N/A	X Walk 2 Width (in)	N/A
	X Walk 1 Slope (%)	2.0		X Walk 2 Slope (%)	N/A
	X Walk 1 X Slope (%)	0.6		X Walk 2 X Slope (%)	N/A

N/A	Ramp inside XWalk1?	N/A	N/A	Ramp inside XWalk2?	N/A
	Road Slope (%)	N/A	N/A	Clear Space?	N/A
	Road X Slope (%)	N/A	N/A	Clear Space to XWalk (in)	N/A
N/A	Any Obstructions?	N/A	N/A	Storm Grate/Utility Hazard?	N/A
	Obstruction Type			Storm Grate/Utility Type	
		N/A			N/A
			Yes	Surface Condition? (G/P)	Good

Possible Solutions:

Remove & Replace Entire Ramp.
