Access Compliance Report Public Rights-of-Way (Curb Ramps)

Intersection ID: 16512 Main Street: AMITY_PL Cross Street: ELM_FOREST_DR Location: SW

ADA ID: EC2A0A83739C Ramp Type: PerpDiag Initial Pass/Fail: Fail Overall Compliance: No Severity Score: 46.25

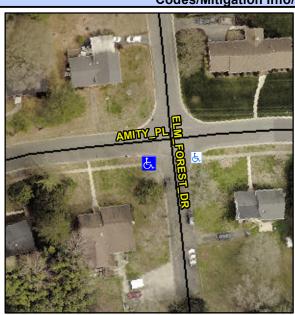
Not Found, R304.5.1, R304.2.2, R304.5.3

No Ramp XSlope (%) No Ramp Width (in) 44.0 N/A N/A Flare Type LT N/A Flare Type RT N/A Flare Slope LT (%) N/A Flare Slope RT (%) N/A N/A Flare Traversable LT? N/A N/A Flare Traversable RT? N/A N/A N/A **DWS Provided?** Landing Length (in) N/A Landing Width (in) N/A N/A **DWS Contrast?** N/A N/A Landing Slope (%) N/A DWS Length (in) N/A Landing X Slope (%) N/A N/A DWS Full Width? N/A Landing Curb? (Y/N) N/A N/A DWS Offset (in) N/A N/A Shared Landing? N/A **Gutter Ponding?** N/A N/A Gutter Slope (%) N/A Gutter Lip Ht (in) N/A N/A Gutter X Slope (%) N/A Painted X Walk1? No N/A Painted X Walk2? X Walk 1 Direction To E X Walk 2 Direction N/A N/A X Walk 1 Width (in) X Walk 2 Width (in) X Walk 1 Slope (%) 3.0 X Walk 2 Slope (%) X Walk 1 X Slope (%) 3.5 X Walk 2 X Slope (%) N/A N/A N/A Ramp inside XWalk2? Ramp inside XWalk1? Road Slope (%) 7.4 N/A Clear Space? N/A Road X Slope (%) 0.5 Clear Space to XWalk (in) N/A N/A Any Obstructions? N/A Storm Grate/Utility Hazard? **Obstruction Type** Storm Grate/Utility Type

Remove & Replace Curb Ramp With Two New Directional Ramps or Equivalent.
