Access Compliance Report

Public Rights-of-Way

(Curb Ramps)

Intersection ID: 28611	Main Street: FALCONCREST_DR	Cross Street: KESTRAL_RIDGE_DR	Location:	N
ADA ID: EC2E1D14E4A4	Ramp Type: PerpDiag	Initial Pass/Fail: Pass	Overall Compliance: No	Severity Score: 2.5
Codes/Mitigation Info/Possible Solution		Field Measurements/Component Compliance

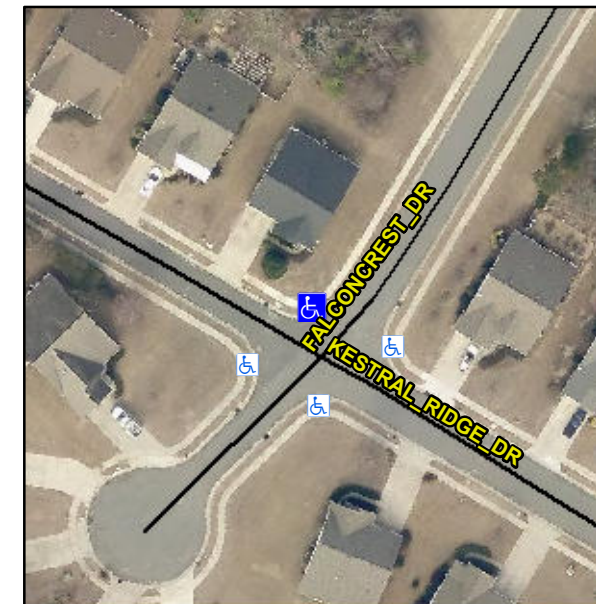
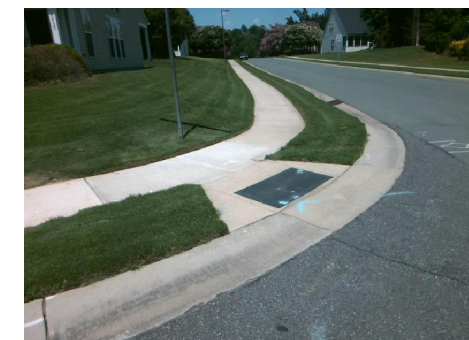
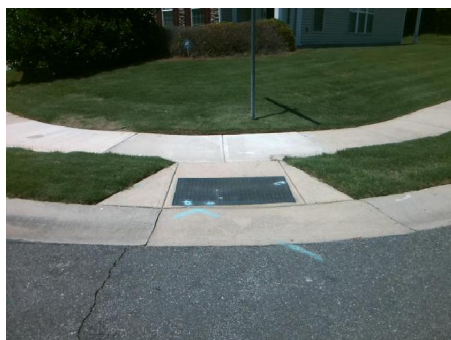
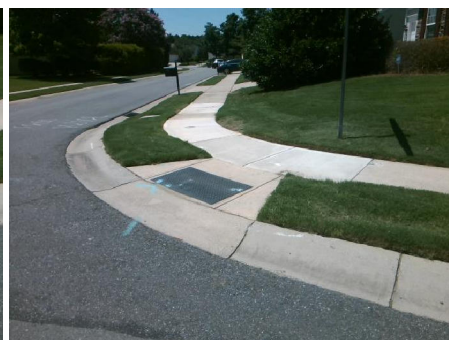
Not Found, R304.2.2-Perp, R304.3.2-Para, R305.1.4, R305.2

Compliance	Description	Data	Compliance	Description	Data
N/A	Ramp Length (in)	48.0	Yes	Ramp Slope (%)	5.5
Yes	Ramp Width (in)	50.0	Yes	Ramp XSlope (%)	0.9
N/A	Flare Type LT	Sloped	N/A	Flare Type RT	N/A
N/A	Flare Slope LT (%)	3.5	N/A	Flare Slope RT (%)	2.6
N/A	Flare Traversable LT?	No	N/A	Flare Traversable RT?	No
Yes	Landing Length (in)	48.0	Yes	DWS Provided?	Yes
Yes	Landing Width (in)	50.0	Yes	DWS Contrast?	Yes
No	Landing Slope (%)	4.6	Yes	DWS Length (in)	25.5
Yes	Landing X Slope (%)	0.7	No	DWS Full Width?	No
N/A	Landing Curb? (Y/N)	No	No	DWS Offset (in)	2.5
N/A	Shared Landing?	No			
Yes	Gutter Ponding?	No	Yes	Gutter Slope (%)	3.5
Yes	Gutter Lip Ht (in)	0.0	Yes	Gutter X Slope (%)	0.5
N/A	Painted X Walk1?	No	N/A	Painted X Walk2?	No
	X Walk 1 Direction	To SW		X Walk 2 Direction	To SE
N/A	X Walk 1 Width (in)	N/A	N/A	X Walk 2 Width (in)	N/A
	X Walk 1 Slope (%)	0.4		X Walk 2 Slope (%)	0.5
	X Walk 1 X Slope (%)	0.7		X Walk 2 X Slope (%)	0.8

N/A	Ramp inside XWalk1?	N/A	N/A	Ramp inside XWalk2?	N/A
	Road Slope (%)	0.3	N/A	Clear Space?	Yes
	Road X Slope (%)	0.5	N/A	Clear Space to XWalk (in)	N/A
Yes	Any Obstructions?	No	Yes	Storm Grate/Utility Hazard?	No
	Obstruction Type			Storm Grate/Utility Type	
		N/A			N/A
			Yes	Surface Condition? (G/P)	Good

Possible Solutions:

Remove & Replace Curb Ramp With Two New Directional Ramps or Equivalent.
