Access Compliance Report

Public Rights-of-Way

(Curb Ramps)

Intersection ID: 30421	Main Street: ANNA_ROSE_RD	Cross Street: ELM_BEND_DR	Location: NE
ADA ID: EC3090D30835	Ramp Type: PerpDiag	Initial Pass/Fail: Fail	Overall Compliance: No
Severity Score: 22.5			
Codes/Mitigation Info/Possible Solution		Field Measurements/Component Compliance

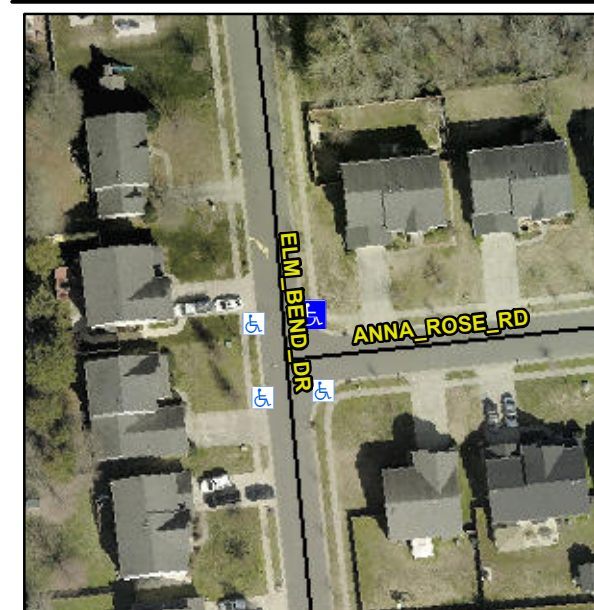
Compliance	Description	Data	Compliance	Description	Data
N/A	Ramp Length (in)	45.0	No	Ramp Slope (%)	10.3
No	Ramp Width (in)	46.0	No	Ramp XSlope (%)	2.8
N/A	Flare Type LT	N/A	N/A	Flare Type RT	N/A
N/A	Flare Slope LT (%)	N/A	N/A	Flare Slope RT (%)	N/A
N/A	Flare Traversable LT?	N/A	N/A	Flare Traversable RT?	N/A
N/A	Landing Length (in)	N/A	N/A	DWS Provided?	N/A
N/A	Landing Width (in)	N/A	N/A	DWS Contrast?	N/A
N/A	Landing Slope (%)	N/A	N/A	DWS Length (in)	N/A
N/A	Landing X Slope (%)	N/A	N/A	DWS Full Width?	N/A
N/A	Landing Curb? (Y/N)	N/A	N/A	DWS Offset (in)	N/A
N/A	Shared Landing?	N/A			
N/A	Gutter Ponding?	N/A	N/A	Gutter Slope (%)	N/A
N/A	Gutter Lip Ht (in)	N/A	N/A	Gutter X Slope (%)	N/A
N/A	Painted X Walk1?	No	N/A	Painted X Walk2?	No
	X Walk 1 Direction	To W		X Walk 2 Direction	To S
N/A	X Walk 1 Width (in)	N/A	N/A	X Walk 2 Width (in)	N/A
	X Walk 1 Slope (%)	1.1		X Walk 2 Slope (%)	0.5
	X Walk 1 X Slope (%)	1.5		X Walk 2 X Slope (%)	0.9

N/A	Ramp inside XWalk1?	N/A	N/A	Ramp inside XWalk2?	N/A
	Road Slope (%)	1.2	N/A	Clear Space?	N/A
	Road X Slope (%)	0.6	N/A	Clear Space to XWalk (in)	N/A
N/A	Any Obstructions?	N/A	N/A	Storm Grate/Utility Hazard?	N/A
	Obstruction Type			Storm Grate/Utility Type	
		N/A			N/A
			Yes	Surface Condition? (G/P)	Good

Possible Solutions:

Remove & Replace Curb Ramp With Two New Directional Ramps or Equivalent.

R304.5.1, R304.2.2, R304.5.3
