Access Compliance Report

Public Rights-of-Way

(Curb Ramps)

Intersection ID: 2750	Main Street: BRADWELL_DR	Cross Street: MANTARIO_DR	Location:	W
ADA ID: EC39EA45C9E2	Ramp Type: PerpDiag	Initial Pass/Fail: Fail	Overall Compliance: No	Severity Score: 22.5
Codes/Mitigation Info/Possible Solution		Field Measurements/Component Compliance

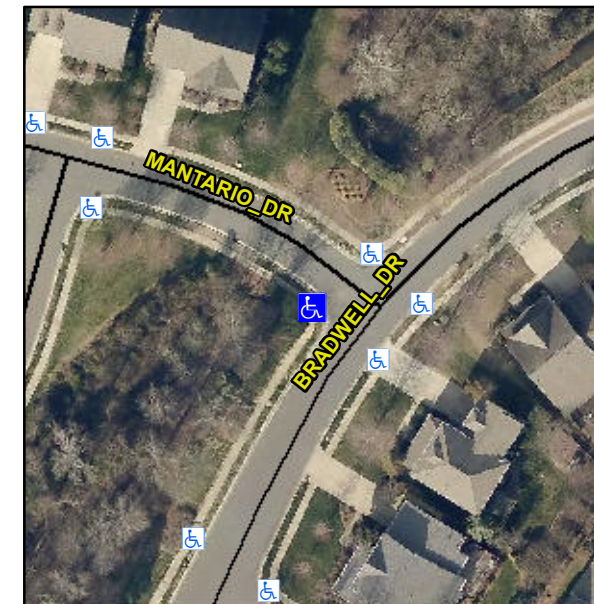
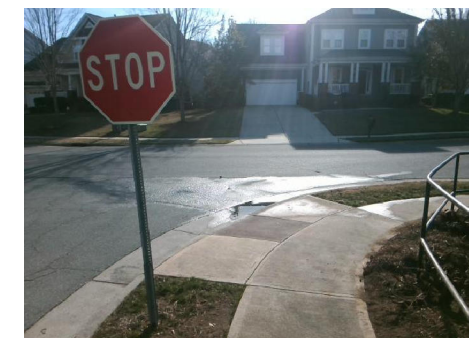
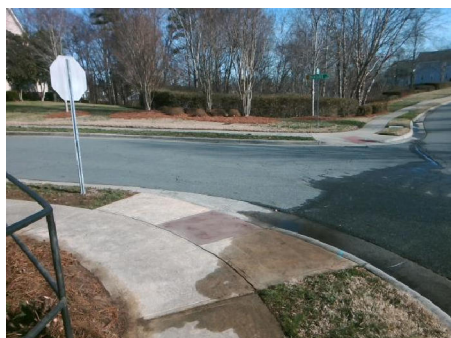
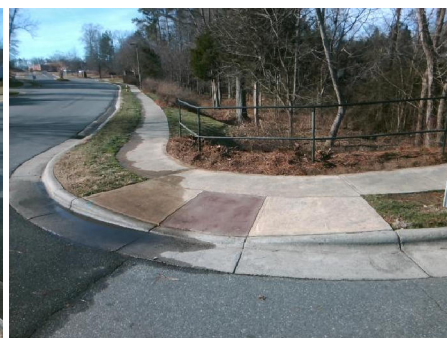
R304.5.1, R304.2.2, R304.5.3

Compliance	Description	Data	Compliance	Description	Data
N/A	Ramp Length (in)	48.0	No	Ramp Slope (%)	10.4
No	Ramp Width (in)	41.0	No	Ramp XSlope (%)	2.1
N/A	Flare Type LT	N/A	N/A	Flare Type RT	N/A
N/A	Flare Slope LT (%)	N/A	N/A	Flare Slope RT (%)	N/A
N/A	Flare Traversable LT?	N/A	N/A	Flare Traversable RT?	N/A
N/A	Landing Length (in)	N/A	N/A	DWS Provided?	N/A
N/A	Landing Width (in)	N/A	N/A	DWS Contrast?	N/A
N/A	Landing Slope (%)	N/A	N/A	DWS Length (in)	N/A
N/A	Landing X Slope (%)	N/A	N/A	DWS Full Width?	N/A
N/A	Landing Curb? (Y/N)	N/A	N/A	DWS Offset (in)	N/A
N/A	Shared Landing?	N/A			
N/A	Gutter Ponding?	N/A	N/A	Gutter Slope (%)	N/A
N/A	Gutter Lip Ht (in)	N/A	N/A	Gutter X Slope (%)	N/A
N/A	Painted X Walk1?	No	N/A	Painted X Walk2?	No
	X Walk 1 Direction	To SE		X Walk 2 Direction	To NE
N/A	X Walk 1 Width (in)	N/A	N/A	X Walk 2 Width (in)	N/A
	X Walk 1 Slope (%)	0.1		X Walk 2 Slope (%)	0.7
	X Walk 1 X Slope (%)	1.9		X Walk 2 X Slope (%)	1.7

N/A	Ramp inside XWalk1?	N/A	N/A	Ramp inside XWalk2?	N/A
	Road Slope (%)	1.7	N/A	Clear Space?	N/A
	Road X Slope (%)	0.7	N/A	Clear Space to XWalk (in)	N/A
N/A	Any Obstructions?	N/A	N/A	Storm Grate/Utility Hazard?	N/A
	Obstruction Type			Storm Grate/Utility Type	
		N/A			N/A
			Yes	Surface Condition? (G/P)	Good

Remove & Replace Curb Ramp With Two New Directional Ramps or Equivalent.
