Access Compliance Report

Public Rights-of-Way

(Curb Ramps)

Intersection ID: 9623	Main Street: BREWTON_DR	Cross Street: PEACEFUL_WAY_DR	Location:	N
ADA ID: EC4C451B038E	Ramp Type: Perp	Initial Pass/Fail: Fail	Overall Compliance: No	Severity Score: 60
Codes/Mitigation Info/Possible Solution		Field Measurements/Component Compliance

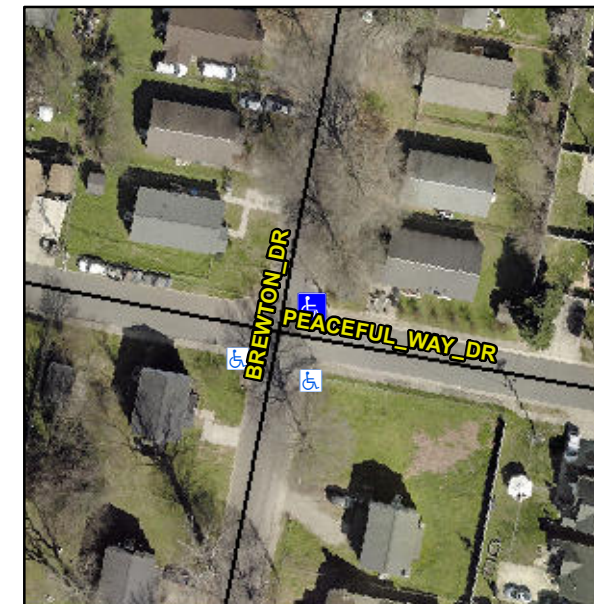
Not Found, R304.5.1, R304.2.2, R304.5.3

Compliance	Description	Data	Compliance	Description	Data
N/A	Ramp Length (in)	45.5	No	Ramp Slope (%)	10.9
No	Ramp Width (in)	20.0	No	Ramp XSlope (%)	5.6
N/A	Flare Type LT	N/A	N/A	Flare Type RT	N/A
N/A	Flare Slope LT (%)	N/A	N/A	Flare Slope RT (%)	N/A
N/A	Flare Traversable LT?	N/A	N/A	Flare Traversable RT?	N/A
N/A	Landing Length (in)	N/A	N/A	DWS Provided?	N/A
N/A	Landing Width (in)	N/A	N/A	DWS Contrast?	N/A
N/A	Landing Slope (%)	N/A	N/A	DWS Length (in)	N/A
N/A	Landing X Slope (%)	N/A	N/A	DWS Full Width?	N/A
N/A	Landing Curb? (Y/N)	N/A	N/A	DWS Offset (in)	N/A
N/A	Shared Landing?	N/A			
N/A	Gutter Ponding?	N/A	N/A	Gutter Slope (%)	N/A
N/A	Gutter Lip Ht (in)	0.5	N/A	Gutter X Slope (%)	N/A
N/A	Painted X Walk1?	No	N/A	Painted X Walk2?	N/A
	X Walk 1 Direction	To S		X Walk 2 Direction	N/A
N/A	X Walk 1 Width (in)	N/A	N/A	X Walk 2 Width (in)	N/A
	X Walk 1 Slope (%)	3.5		X Walk 2 Slope (%)	N/A
	X Walk 1 X Slope (%)	3.2		X Walk 2 X Slope (%)	N/A

Remove & Replace Entire Ramp.

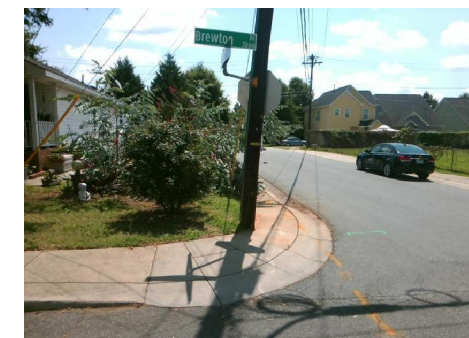
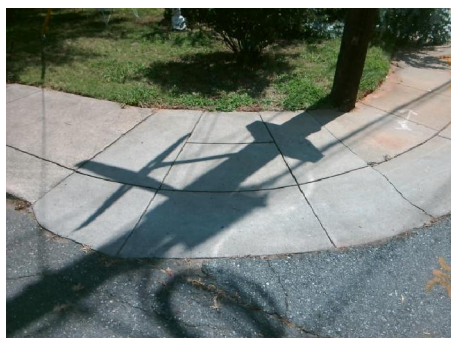
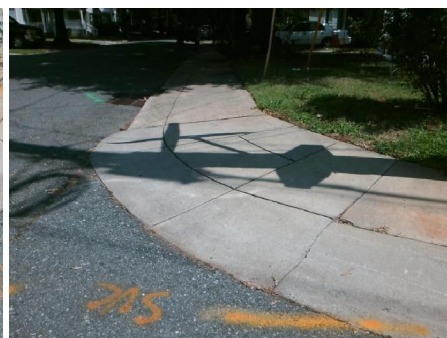
N/A	Ramp inside XWalk1?	N/A	N/A	Ramp inside XWalk2?	N/A
	Road Slope (%)	N/A	N/A	Clear Space?	N/A
	Road X Slope (%)	N/A	N/A	Clear Space to XWalk (in)	N/A
N/A	Any Obstructions?	N/A	N/A	Storm Grate/Utility Hazard?	N/A
	Obstruction Type			Storm Grate/Utility Type	
		N/A			N/A
			Yes	Surface Condition? (G/P)	Good
