Access Compliance Report

Public Rights-of-Way

(Curb Ramps)

Intersection ID: 53537	Main Street: MACFARLANE_BV	Cross Street: IKEA_BV	Location:	E
ADA ID: EC4C7FEE2456	Ramp Type: Perp	Initial Pass/Fail: Fail	Overall Compliance: No	Severity Score: 1.25

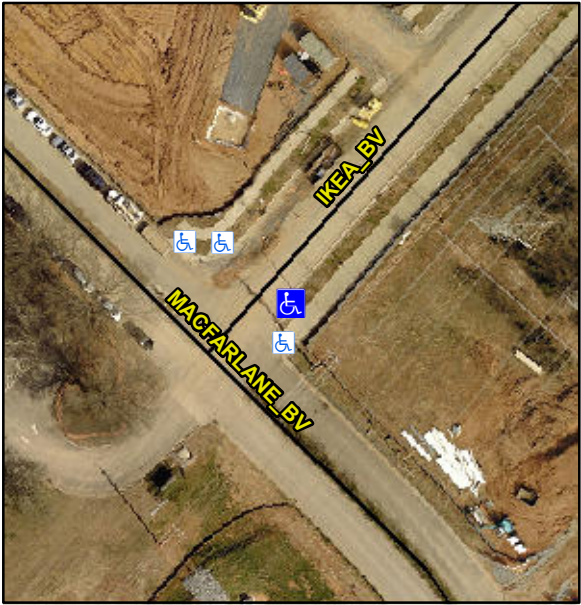
Possible Solutions:		Compliance	Description	Data
	Remove & Replace Entire Ramp.		Yes	Ramp Length (in)	81.0
			N/A	Ramp Width (in)	48.0
			N/A	Flare Type LT	N/A
			N/A	Flare Slope LT (%)	N/A
			N/A	Flare Traversable LT?	N/A
			N/A	Flare Traversable RT?	N/A
			N/A	Landing Length (in)	N/A
			N/A	Landing Width (in)	N/A
			N/A	Landing Slope (%)	N/A
<p>Surveyor Notes:</p> <p>N/A</p> <p>PROW/ADA:</p> <p>Not Found, R304.5.3</p>			Yes	Ramp Slope (%)	8.0
			No	Ramp XSlope (%)	2.6
			N/A	Flare Type RT	N/A
			N/A	Flare Slope RT (%)	N/A
			N/A	Flare Traversable RT?	N/A
			N/A	DWS Provided?	N/A
			N/A	DWS Contrast?	N/A
			N/A	DWS Length (in)	N/A
			N/A	DWS Full Width?	N/A
			N/A	DWS Offset (in)	N/A
			N/A	Shared Landing?	N/A
			N/A	Gutter Ponding?	N/A
			N/A	Gutter Lip Ht (in)	2.5
			No	Painted X Walk1?	N/A
				X Walk 1 Direction	To NW
			N/A	X Walk 1 Width (in)	N/A

X Walk 1 Slope (%)	0.2
				X Walk 1 X Slope (%)	2.8
			N/A	Ramp inside XWalk1?	N/A
			N/A	Ramp inside XWalk2?	N/A
			N/A	Road Slope (%)	N/A
			N/A	Road X Slope (%)	N/A
			N/A	Clear Space?	N/A
			N/A	Clear Space to XWalk (in)	N/A
			N/A	Storm Grate/Utility Hazard?	N/A
				Storm Grate/Utility Type	
			N/A		N/A
			Yes	Surface Condition? (G/P)	Good
Total Cost:		\$ 1850.00
