Access Compliance Report

Public Rights-of-Way

(Curb Ramps)

Intersection ID: 28238	Main Street: ADDINGTON_CT	Cross Street: DARBY_CHASE_DR	Location: NW
ADA ID: EC5CC328491D	Ramp Type: Perp	Initial Pass/Fail: Fail	Overall Compliance: No
			Severity Score: 36.25

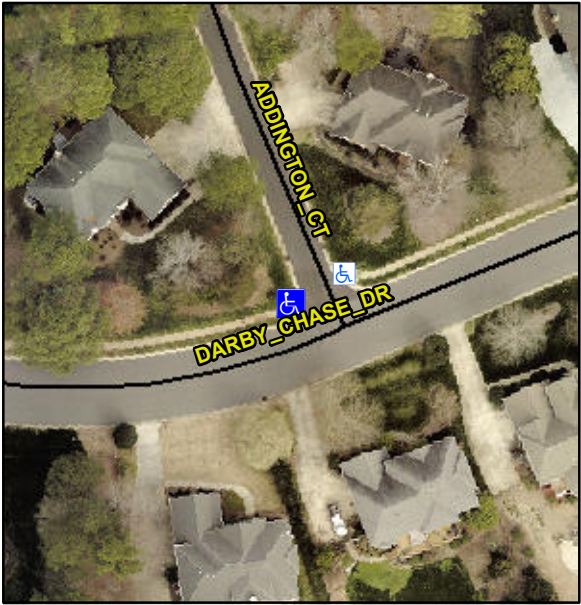
Possible Solutions:		Compliance	Description	Data
	Remove & Replace Entire Ramp.		Yes	Ramp Length (in)	55.5
			No	Ramp Width (in)	26.0
			N/A	Flare Type LT	N/A
			N/A	Flare Slope LT (%)	N/A
			N/A	Flare Traversable LT?	N/A
			N/A	Landing Length (in)	N/A
			N/A	Landing Width (in)	N/A
			N/A	Landing Slope (%)	N/A
			N/A	Landing X Slope (%)	N/A
<p>Surveyor Notes:</p> <p>N/A</p> <p>PROW/ADA:</p> <p>Not Found, R304.5.1, R304.5.3</p>			N/A	Flare Type RT	N/A
			N/A	Flare Slope RT (%)	N/A
			N/A	Flare Traversable RT?	N/A
			N/A	DWS Provided?	N/A
			N/A	DWS Contrast?	N/A
			N/A	DWS Length (in)	N/A
			N/A	DWS Full Width?	N/A
			N/A	DWS Offset (in)	N/A
			N/A	Gutter Ponding?	N/A
			N/A	Gutter Lip Ht (in)	N/A
			No	Painted X Walk1?	N/A
				X Walk 1 Direction	To NE
			N/A	X Walk 1 Width (in)	N/A
				X Walk 1 Slope (%)	2.2
				X Walk 1 X Slope (%)	2.4

N/A	Ramp inside XWalk1?	N/A
			N/A	Road Slope (%)	N/A
			N/A	Road X Slope (%)	N/A
			N/A	Any Obstructions?	N/A
				Obstruction Type	
Total Cost:					
					\$ 1850.00
			N/A	Clear Space?	N/A
			N/A	Clear Space to XWalk (in)	N/A
			N/A	Storm Grate/Utility Hazard?	N/A
				Storm Grate/Utility Type	
			N/A		N/A
			Yes	Surface Condition? (G/P)	Good
