Access Compliance Report

Public Rights-of-Way

(Curb Ramps)

Intersection ID: 6687	Main Street: NEVIN_RD	Cross Street: KAYRON_DR	Location: NW
ADA ID: EC65D07EE02C	Ramp Type: Directional1	Initial Pass/Fail: Fail	Overall Compliance: No
Severity Score: 25			
Codes/Mitigation Info/Possible Solution		Field Measurements/Component Compliance

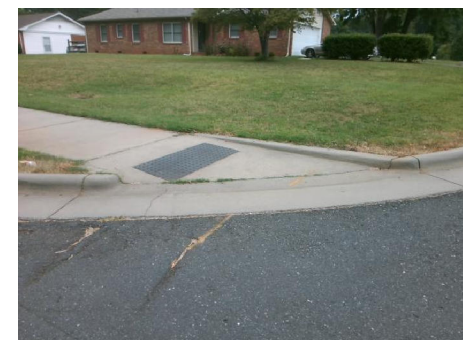
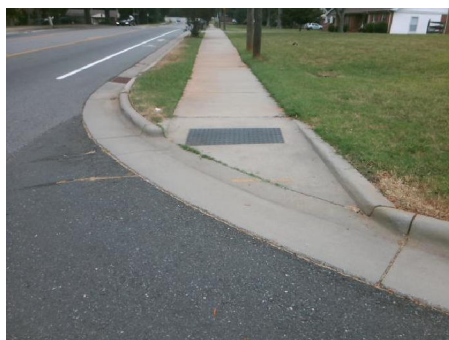
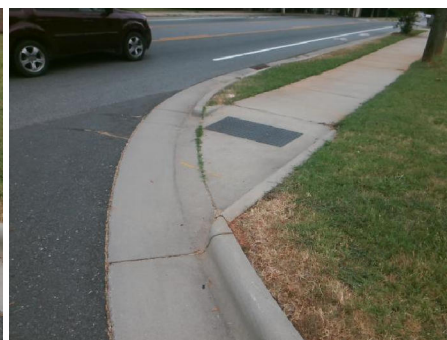
Compliance	Description	Data	Compliance	Description	Data
N/A	Ramp Length (in)	27.0	N/A	Grade Break?	N/A
Yes	Ramp Width (in)	69.0	N/A	Grade Break Slope (%)	0.0
Yes	Ramp Slope (%)	7.5	N/A	Grade Break XSlope (%)	0.0
No	Ramp XSlope (%)	7.0			
N/A	Flare Type LT	N/A	N/A	Flare Type RT	N/A
N/A	Flare Slope LT (%)	N/A	N/A	Flare Slope RT (%)	0.0
N/A	Flare Traversable LT?	N/A	N/A	Flare Traversable RT?	N/A
N/A	Landing Length (in)	0.0	N/A	DWS Provided?	N/A
N/A	Landing Width (in)	0.0	N/A	DWS Contrast?	N/A
N/A	Landing Slope (%)	0.0	N/A	DWS Length (in)	N/A
N/A	Landing X Slope (%)	0.0	N/A	DWS Full Width?	N/A
N/A	Landing Curb? (Y/N)	N/A	N/A	DWS Offset LT (in)	N/A
N/A	Shared Landing?	N/A	N/A	DWS Offset RT (in)	N/A
N/A	Gutter Ponding?	0.0	N/A	Gutter Slope (%)	N/A
N/A	Gutter Lip Ht (in)	0.0	N/A	Gutter X Slope (%)	N/A
N/A	Painted X Walk1?	No		Road Slope (%)	4.0
	X Walk 1 Direction	To E		Road X Slope (%)	8.4
	X Walk 1 Width (in)	N/A		Clear Space?	N/A

X Walk 1 Slope (%)	4.0	N/A	Clear Space to XWalk (in)	N/A
	X Walk 1 X Slope (%)	8.4	N/A	Storm Grate/Utility Hazard?	N/A
N/A	Ramp inside XWalk1?	N/A		Storm Grate/Utility Type	
N/A	Any Obstructions?	N/A			N/A
	Obstruction Type		Yes	Surface Condition? (G/P)	Good
			N/A	Curb Slope (%)	14.6

Possible Solutions:

Remove & Replace Entire Ramp.
