Access Compliance Report

Public Rights-of-Way

(Curb Ramps)

Intersection ID: 19216	Main Street: RAMA_RD	Cross Street: SARDIS_RD	Location: SE
ADA ID: EC68B9C03073	Ramp Type: IslandPerp	Initial Pass/Fail: Fail	Overall Compliance: No
		Severity Score: 1.25

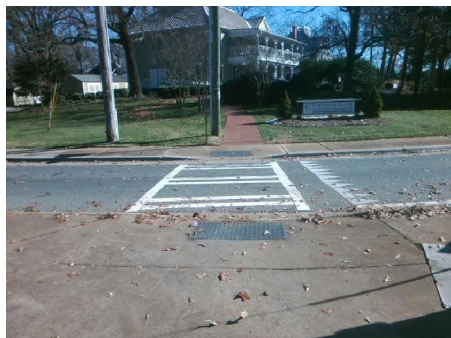
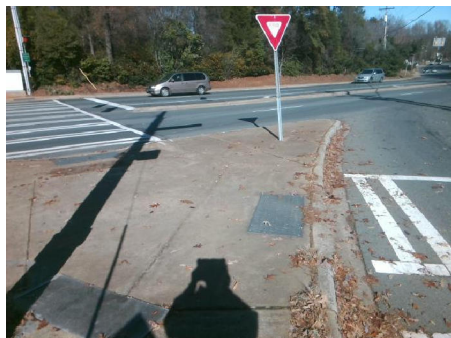
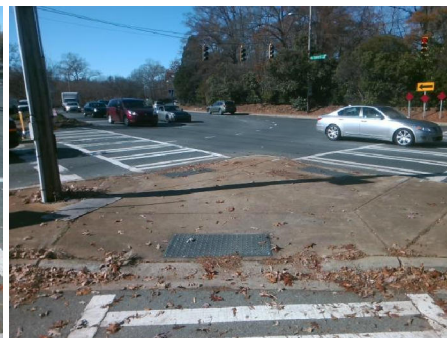
Not Found, R304.5.3

Compliance	Description	Data	Compliance	Description	Data
N/A	Ramp Length (in)	59.0	Yes	Ramp Slope (%)	1.8
Yes	Ramp Width (in)	48.0	No	Ramp XSlope (%)	2.1
N/A	Flare Type LT	N/A	N/A	Flare Type RT	N/A
N/A	Flare Slope LT (%)	N/A	N/A	Flare Slope RT (%)	N/A
N/A	Flare Traversable LT?	N/A	N/A	Flare Traversable RT?	N/A
N/A	Landing Length (in)	N/A	N/A	DWS Provided?	N/A
N/A	Landing Width (in)	N/A	N/A	DWS Contrast?	N/A
N/A	Landing Slope (%)	N/A	N/A	DWS Length (in)	N/A
N/A	Landing X Slope (%)	N/A	N/A	DWS Full Width?	N/A
N/A	Landing Curb? (Y/N)	N/A	N/A	DWS Offset (in)	N/A
N/A	Shared Landing?	N/A			
N/A	Gutter Ponding?	N/A	N/A	Gutter Slope (%)	N/A
N/A	Gutter Lip Ht (in)	N/A	N/A	Gutter X Slope (%)	N/A
N/A	Painted X Walk1?	Yes	N/A	Painted X Walk2?	N/A
	X Walk 1 Direction	To SE		X Walk 2 Direction	N/A
N/A	X Walk 1 Width (in)	103.0	N/A	X Walk 2 Width (in)	N/A
	X Walk 1 Slope (%)	0.2		X Walk 2 Slope (%)	N/A
	X Walk 1 X Slope (%)	1.3		X Walk 2 X Slope (%)	N/A

N/A	Ramp inside XWalk1?	Yes	N/A	Ramp inside XWalk2?	N/A
	Road Slope (%)	N/A	N/A	Clear Space?	N/A
	Road X Slope (%)	N/A	N/A	Clear Space to XWalk (in)	N/A
N/A	Any Obstructions?	N/A	N/A	Storm Grate/Utility Hazard?	N/A
	Obstruction Type			Storm Grate/Utility Type	
		N/A			N/A
			Yes	Surface Condition? (G/P)	Good

Remove & Replace Entire Ramp.
