| Intersection ID: 12687 | Main Street: BROWNING_AV | Cross Street: NASSAU_BV | Location: | SE |
| ADA ID: EC975779B2CE | Ramp Type: Perp | Initial Pass/Fail: Fail | Overall Compliance: No | Severity Score: 21.25 |

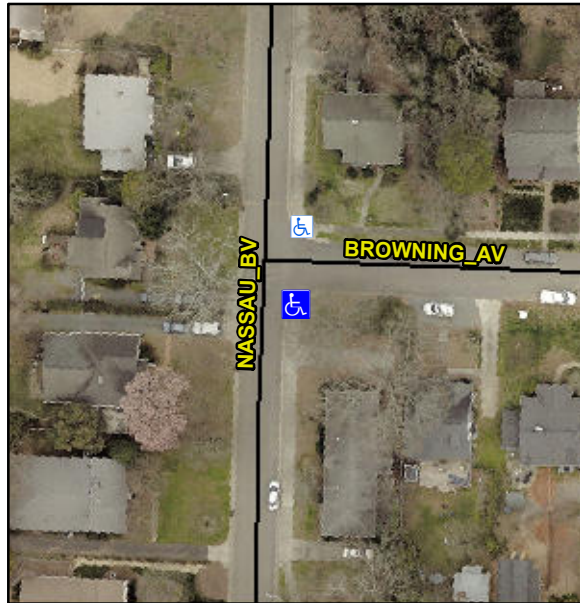
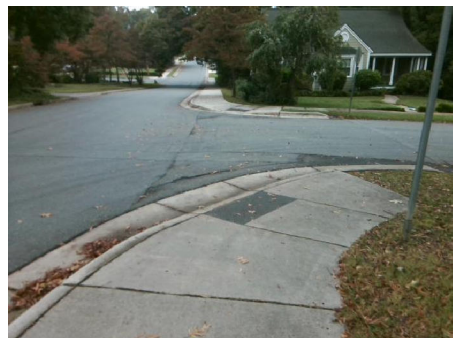
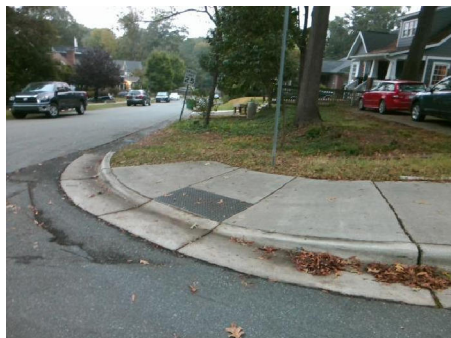
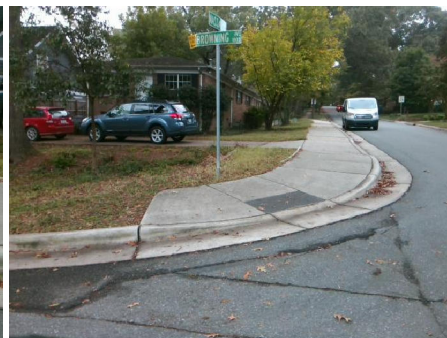
**Not Found, R304.5.1, R304.5.3**

| Possible Solutions: | | | Compliance | Description | Data | Compliance | Description | Data |
|---|---|---|---|---|---|---|---|---|
| Remove & Replace Entire Ramp. | N/A | Ramp Length (in) | 72.0 | Yes | Ramp Slope (%) | 7.0 | | |
| | No | Ramp Width (in) | 42.5 | No | Ramp XSlope (%) | 6.1 | | |

### Remove & Replace Entire Ramp.
