Access Compliance Report

Public Rights-of-Way

(Curb Ramps)

| Intersection ID: 10023889 | Main Street: COMMUNITY_HOUSE_RD | Cross Street: N/A | Location: SW |

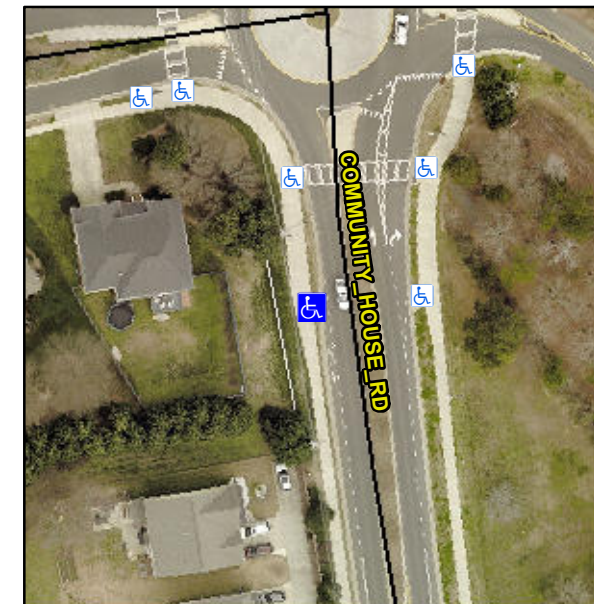
| ADA ID: EC9A6C0E5D22 | Ramp Type: Perp | Initial Pass/Fail: Fail | Overall Compliance: No |

R304.2.2

| Compliance | Description | Data | Compliance | Description | Data |
|---|---|---|---|---|---|
| N/A | Ramp Length (in) | 45.0 | No | Ramp Slope (%) | 14.9 |
| Yes | Ramp Width (in) | 116.0 | Yes | Ramp XSlope (%) | 1.7 |

Remove & Replace Entire Ramp.

\$ 1850.00
