Access Compliance Report

Public Rights-of-Way

(Curb Ramps)

Intersection ID: 21252	Main Street: W_ARROWOOD_RD	Cross Street: N_I-77_EXIT_3_RA	Location:	N
ADA ID: ECA08A20B67C	Ramp Type: Perp	Initial Pass/Fail: Fail	Overall Compliance: No	Severity Score: 10
Codes/Mitigation Info/Possible Solution		Field Measurements/Component Compliance

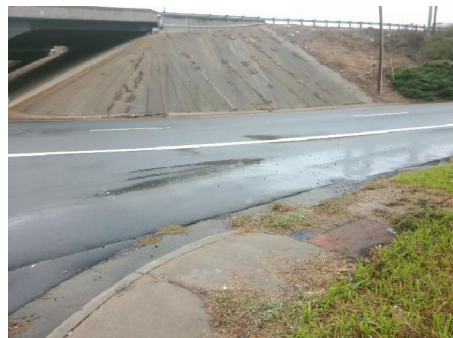
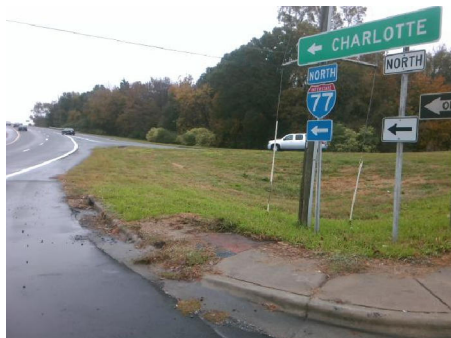
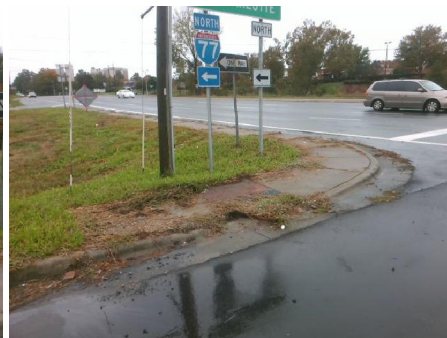
Not Found, R304.5.1

Compliance	Description	Data	Compliance	Description	Data
N/A	Ramp Length (in)	60.0	Yes	Ramp Slope (%)	6.9
No	Ramp Width (in)	45.0	Yes	Ramp XSlope (%)	2.9
N/A	Flare Type LT	N/A	N/A	Flare Type RT	N/A
N/A	Flare Slope LT (%)	N/A	N/A	Flare Slope RT (%)	N/A
N/A	Flare Traversable LT?	N/A	N/A	Flare Traversable RT?	N/A
N/A	Landing Length (in)	N/A	N/A	DWS Provided?	N/A
N/A	Landing Width (in)	N/A	N/A	DWS Contrast?	N/A
N/A	Landing Slope (%)	N/A	N/A	DWS Length (in)	N/A
N/A	Landing X Slope (%)	N/A	N/A	DWS Full Width?	N/A
N/A	Landing Curb? (Y/N)	N/A	N/A	DWS Offset (in)	N/A
N/A	Shared Landing?	N/A			
N/A	Gutter Ponding?	N/A	N/A	Gutter Slope (%)	N/A
N/A	Gutter Lip Ht (in)	N/A	N/A	Gutter X Slope (%)	N/A
N/A	Painted X Walk1?	No	N/A	Painted X Walk2?	N/A
	X Walk 1 Direction	To W		X Walk 2 Direction	N/A
N/A	X Walk 1 Width (in)	N/A	N/A	X Walk 2 Width (in)	N/A
	X Walk 1 Slope (%)	0.7		X Walk 2 Slope (%)	N/A
	X Walk 1 X Slope (%)	3.0		X Walk 2 X Slope (%)	N/A

Remove & Replace Entire Ramp.

Total Cost: \$ 1850.00
